# **2021 Annual Monitoring Report**

**Highway 96 Site  
White Bear Township, Minnesota**

Highway 96 Site PRP Group

March 15, 2022

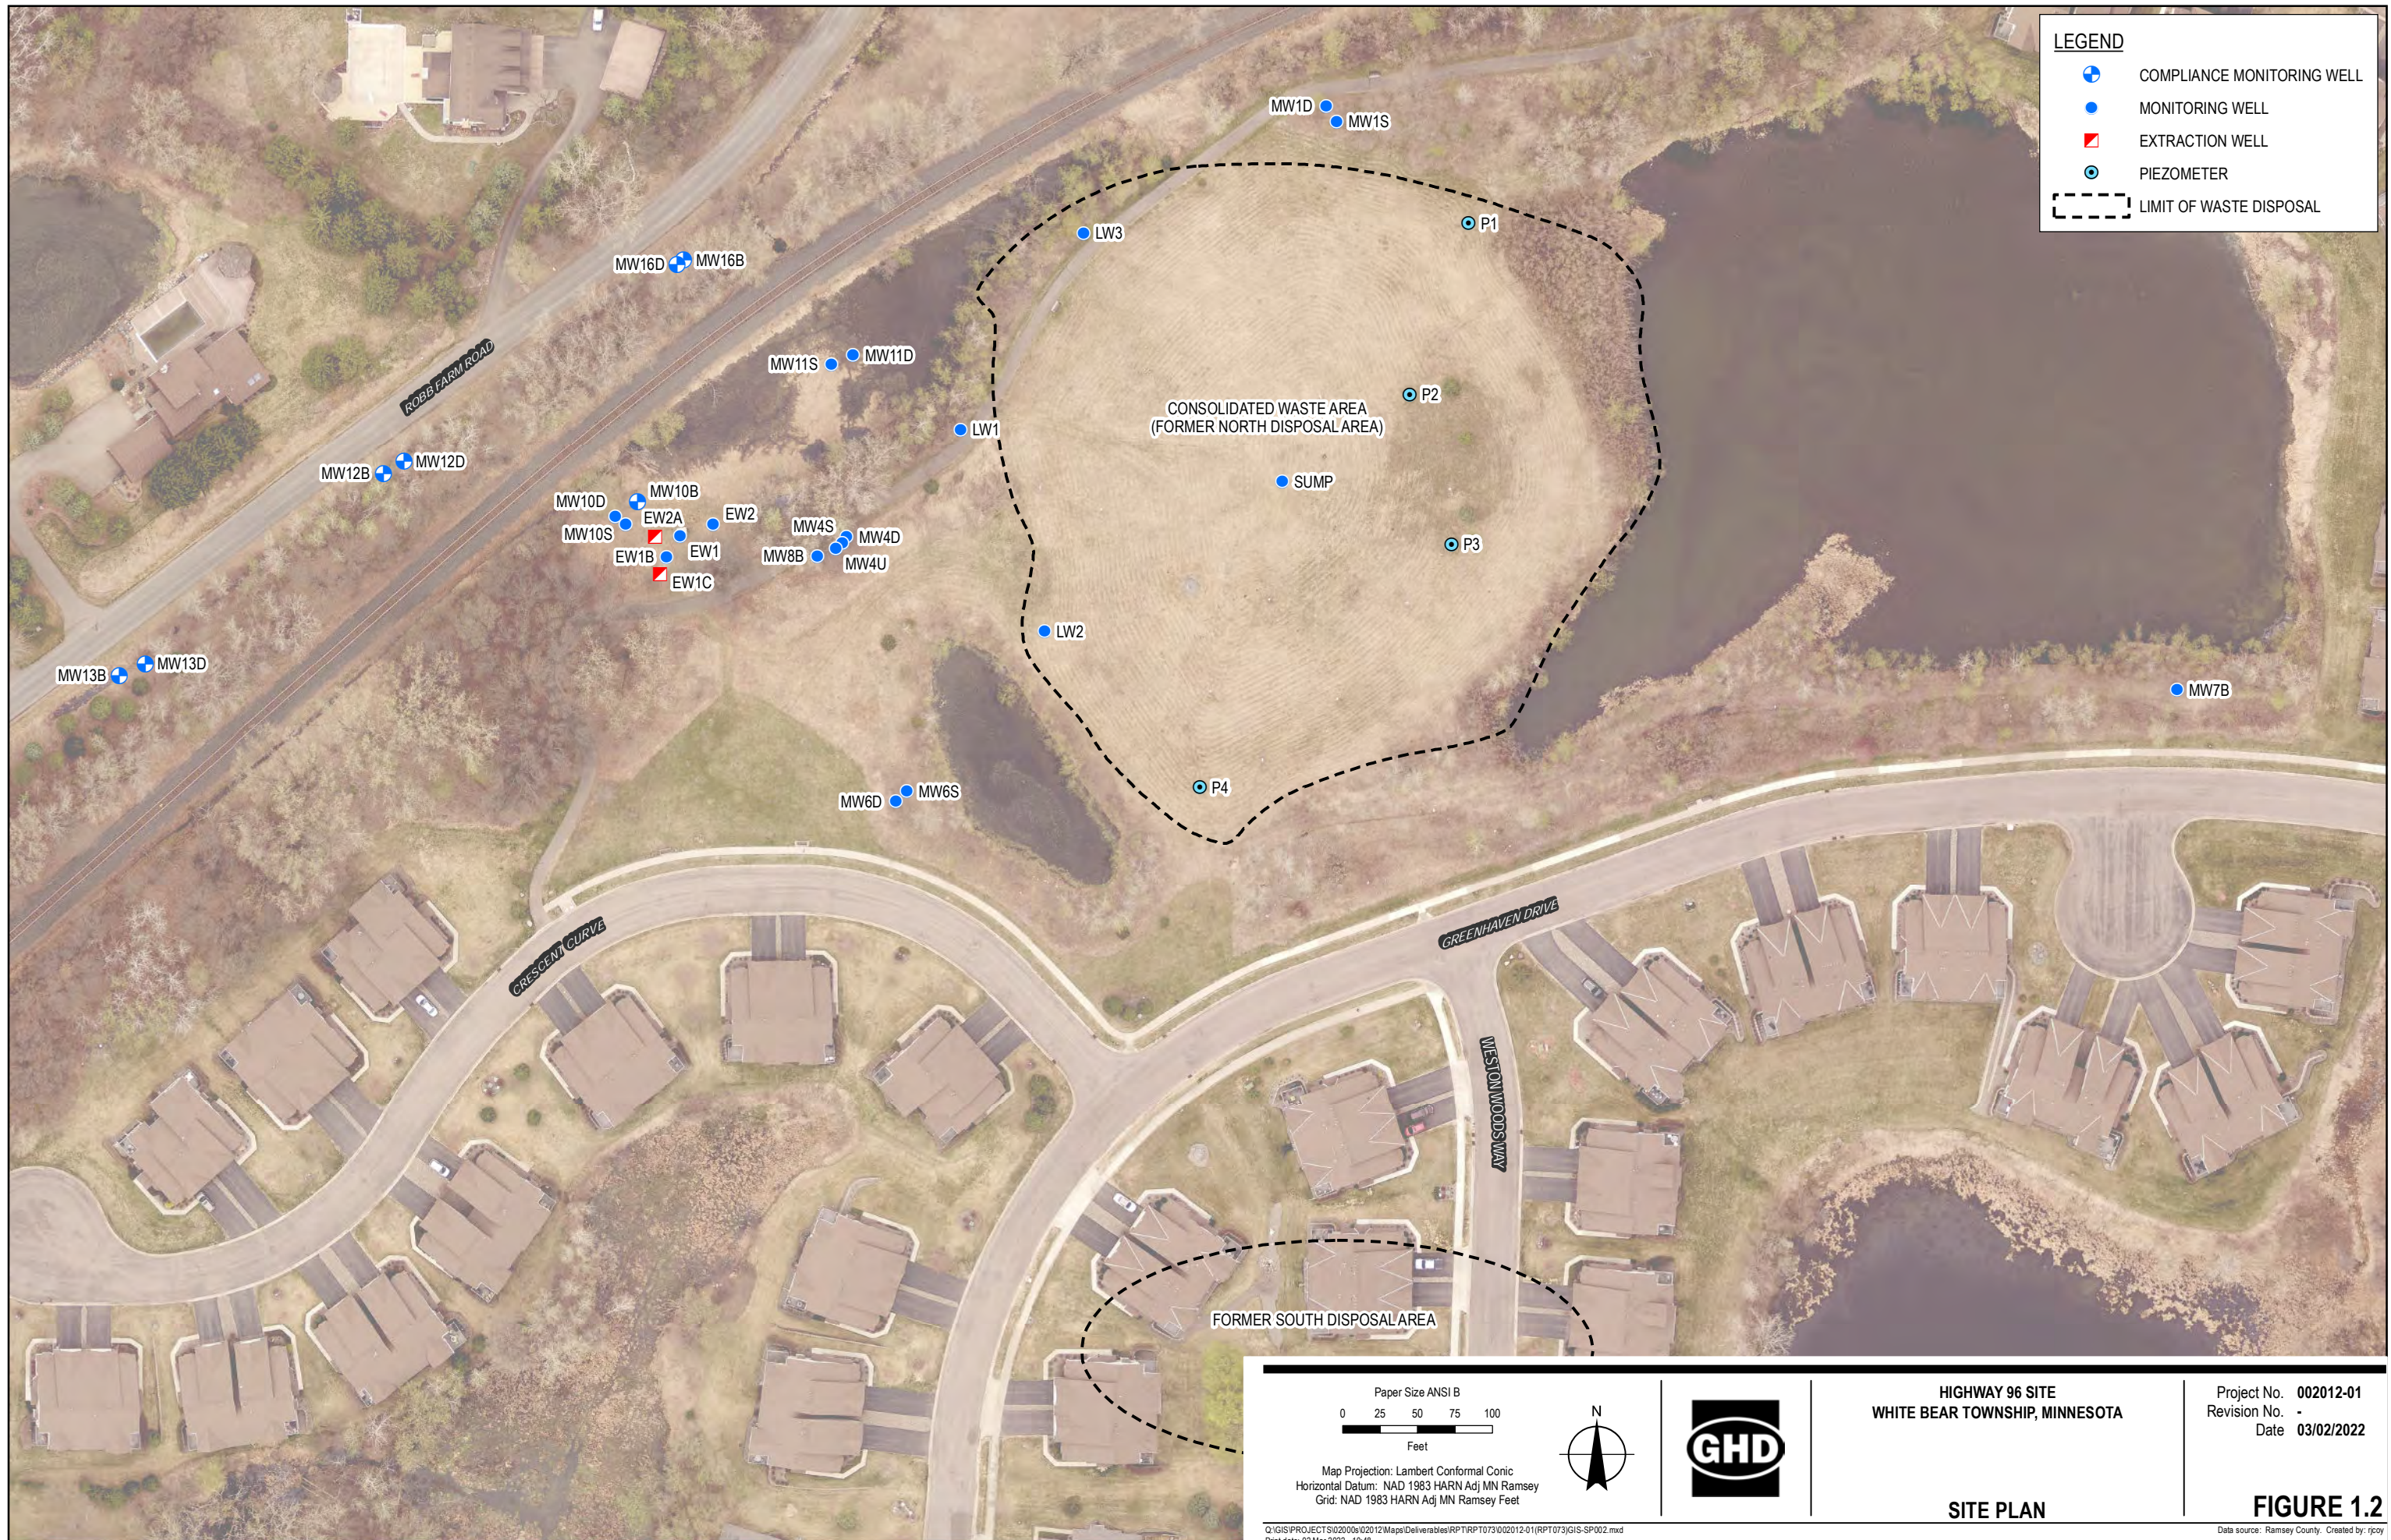
**FIGURE 1.2**

**SITE PLAN**

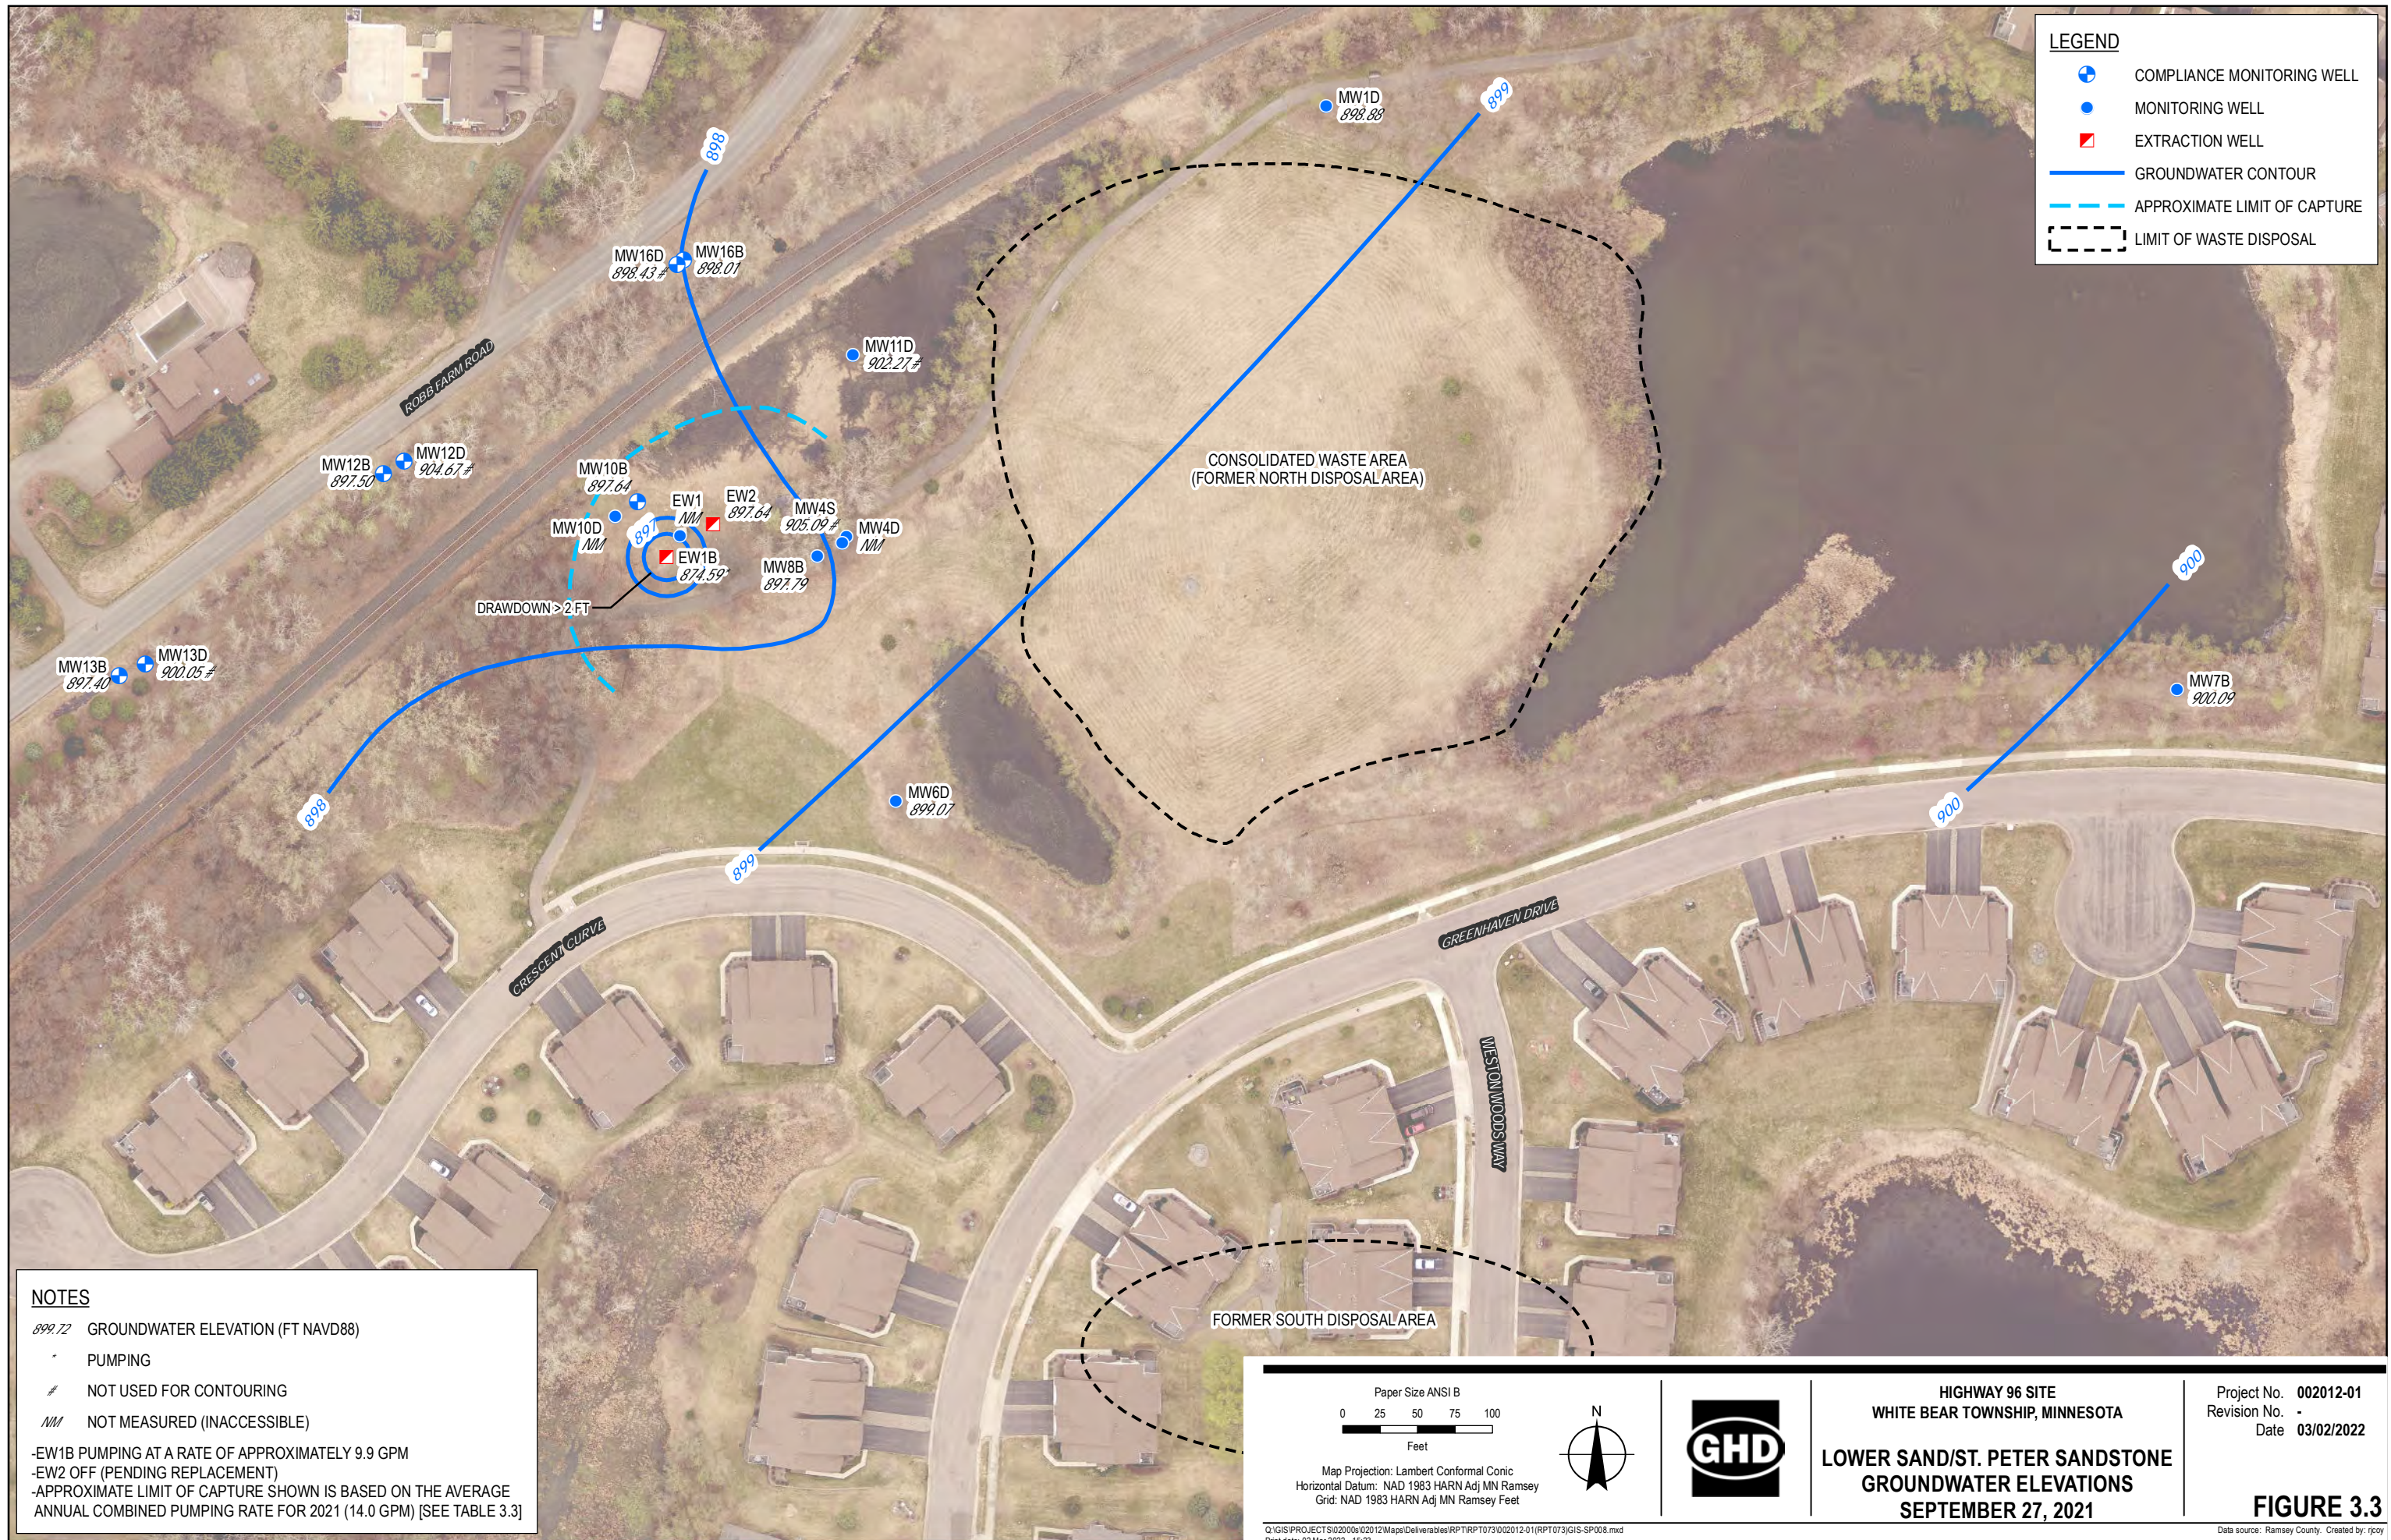
**FIGURE 3.3**

September 2021 groundwater contours for the Lower Sand/St. Peter Sandstone aquifers on-Site are presented on Figure 3.3. The groundwater contours depict the hydraulic influence of the on-Site groundwater extraction system (see Section 3.3). Overall, groundwater elevations continue to reflect the heterogeneous nature of the Lower Sand aquifer. As noted on Figure 3.3, some Lower Sand aquifer monitoring locations are not used for groundwater contouring because they are screened in areas of low permeability soil (i.e., higher silt/clay content).

Paper Size ANSI B 0 25 50 75 100 Feet			<b>HIGHWAY 96 SITE</b> WHITE BEAR TOWNSHIP, MINNESOTA <b>LOWER SAND/ST. PETER SANDSTONE</b> <b>GROUNDWATER ELEVATIONS</b> SEPTEMBER 27, 2021	Project No. 002012-01 Revision No. - Date 03/02/2022
---	--	--	--	--

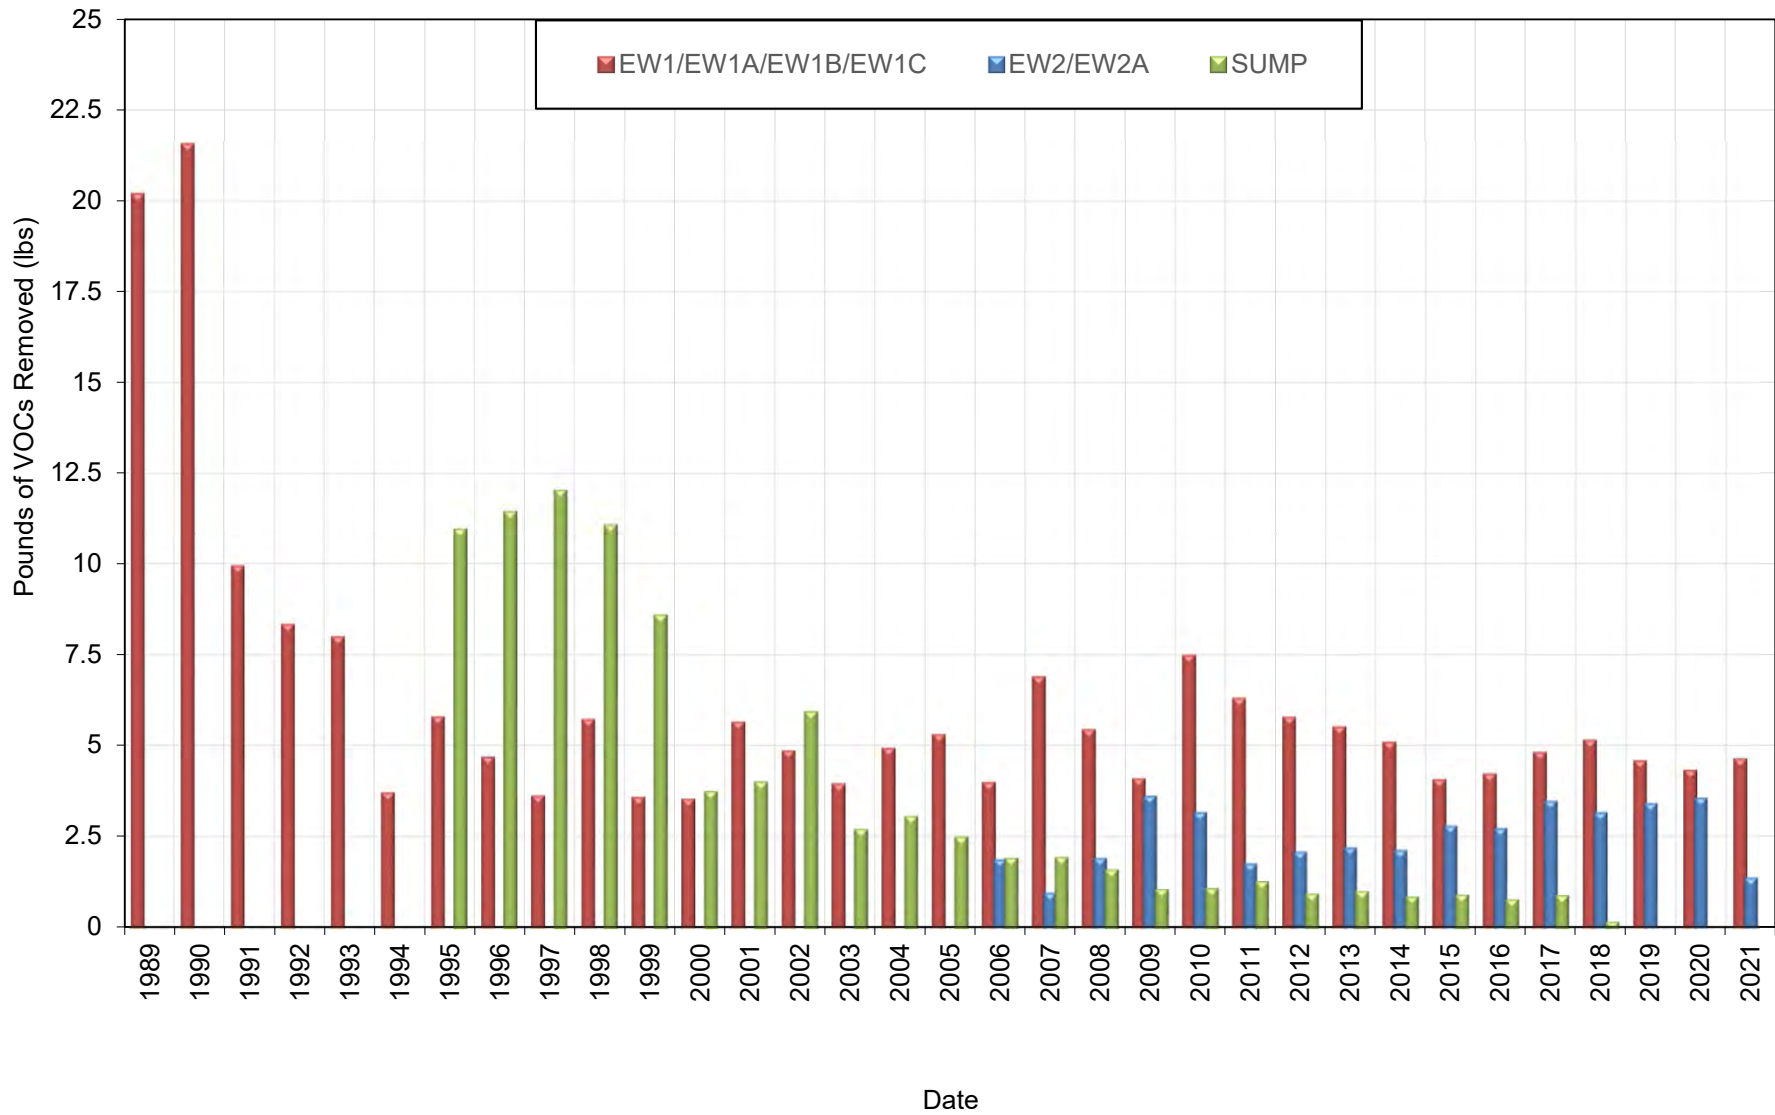
Figure 3.7

Historical VOC Mass Removal  
Highway 96 Site  
White Bear Township, Minnesota

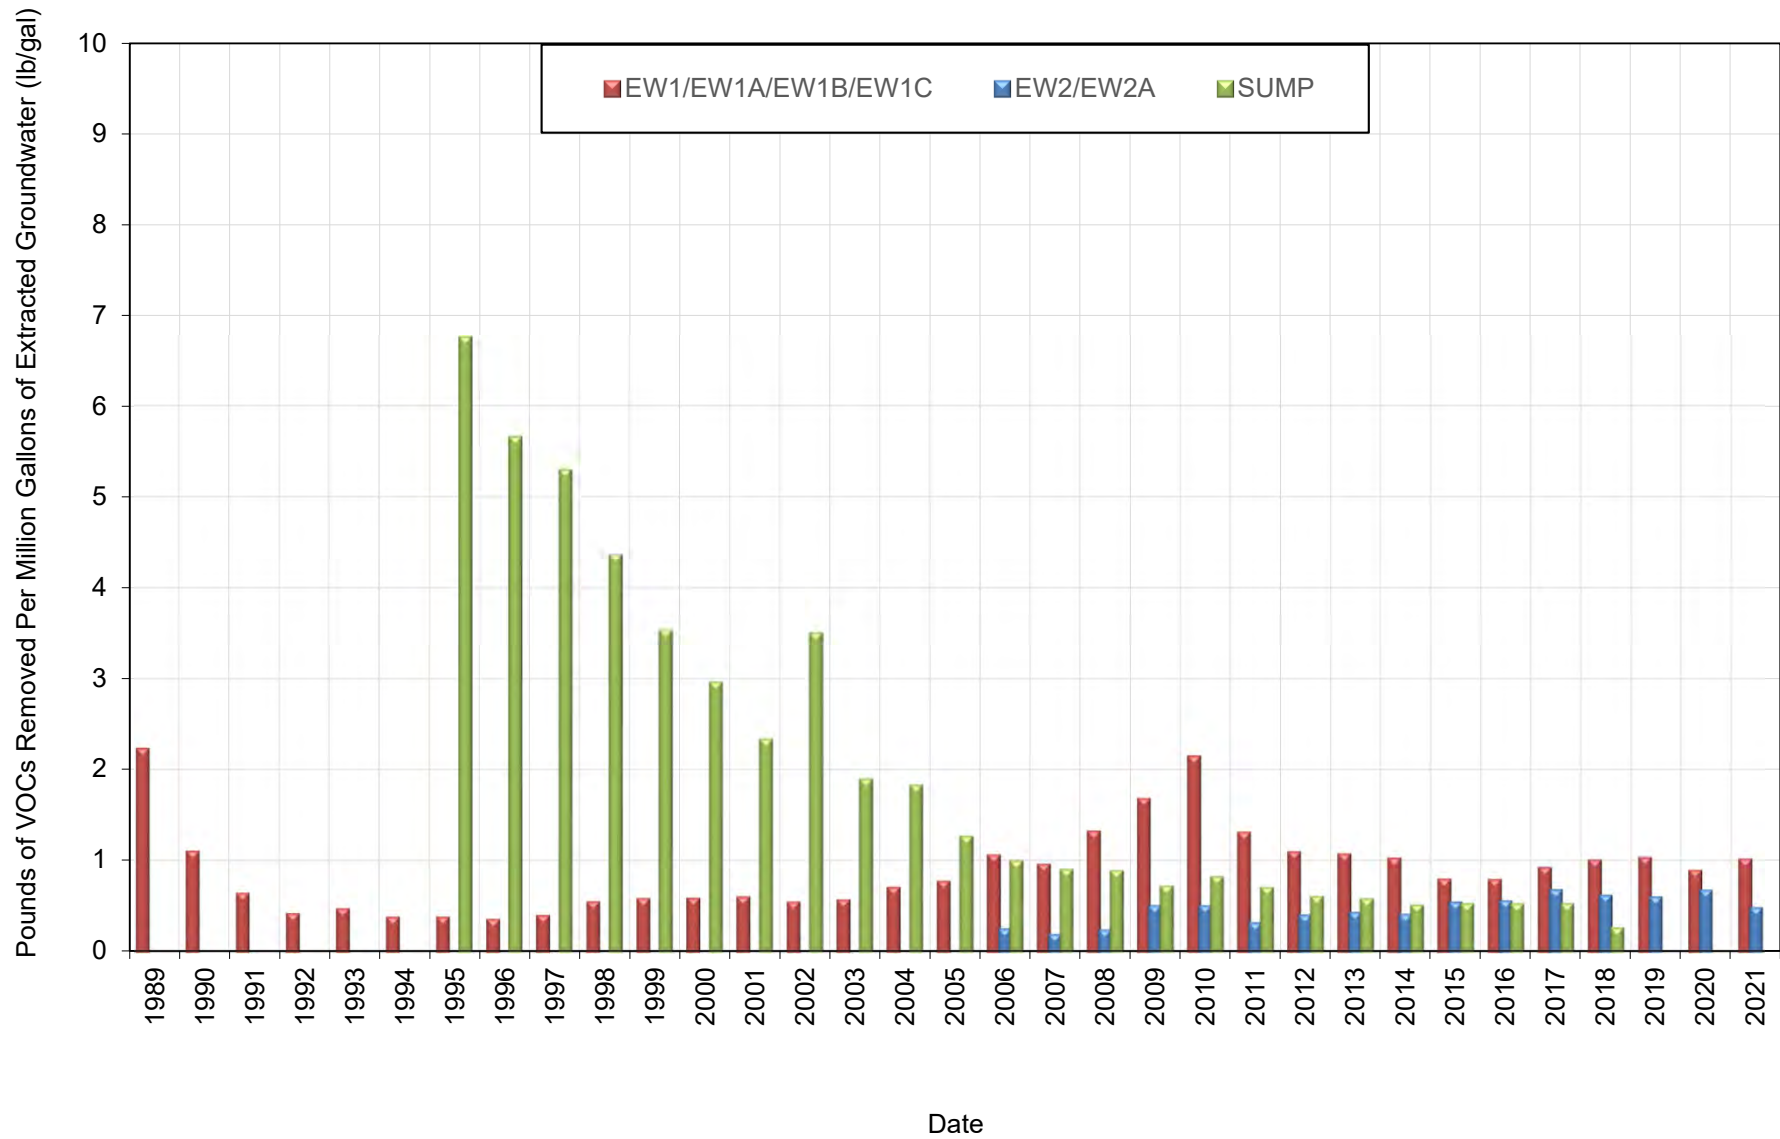
Figure 3.8

Historical VOC Mass Removal Efficiency  
Highway 96 Site  
White Bear Township, Minnesota

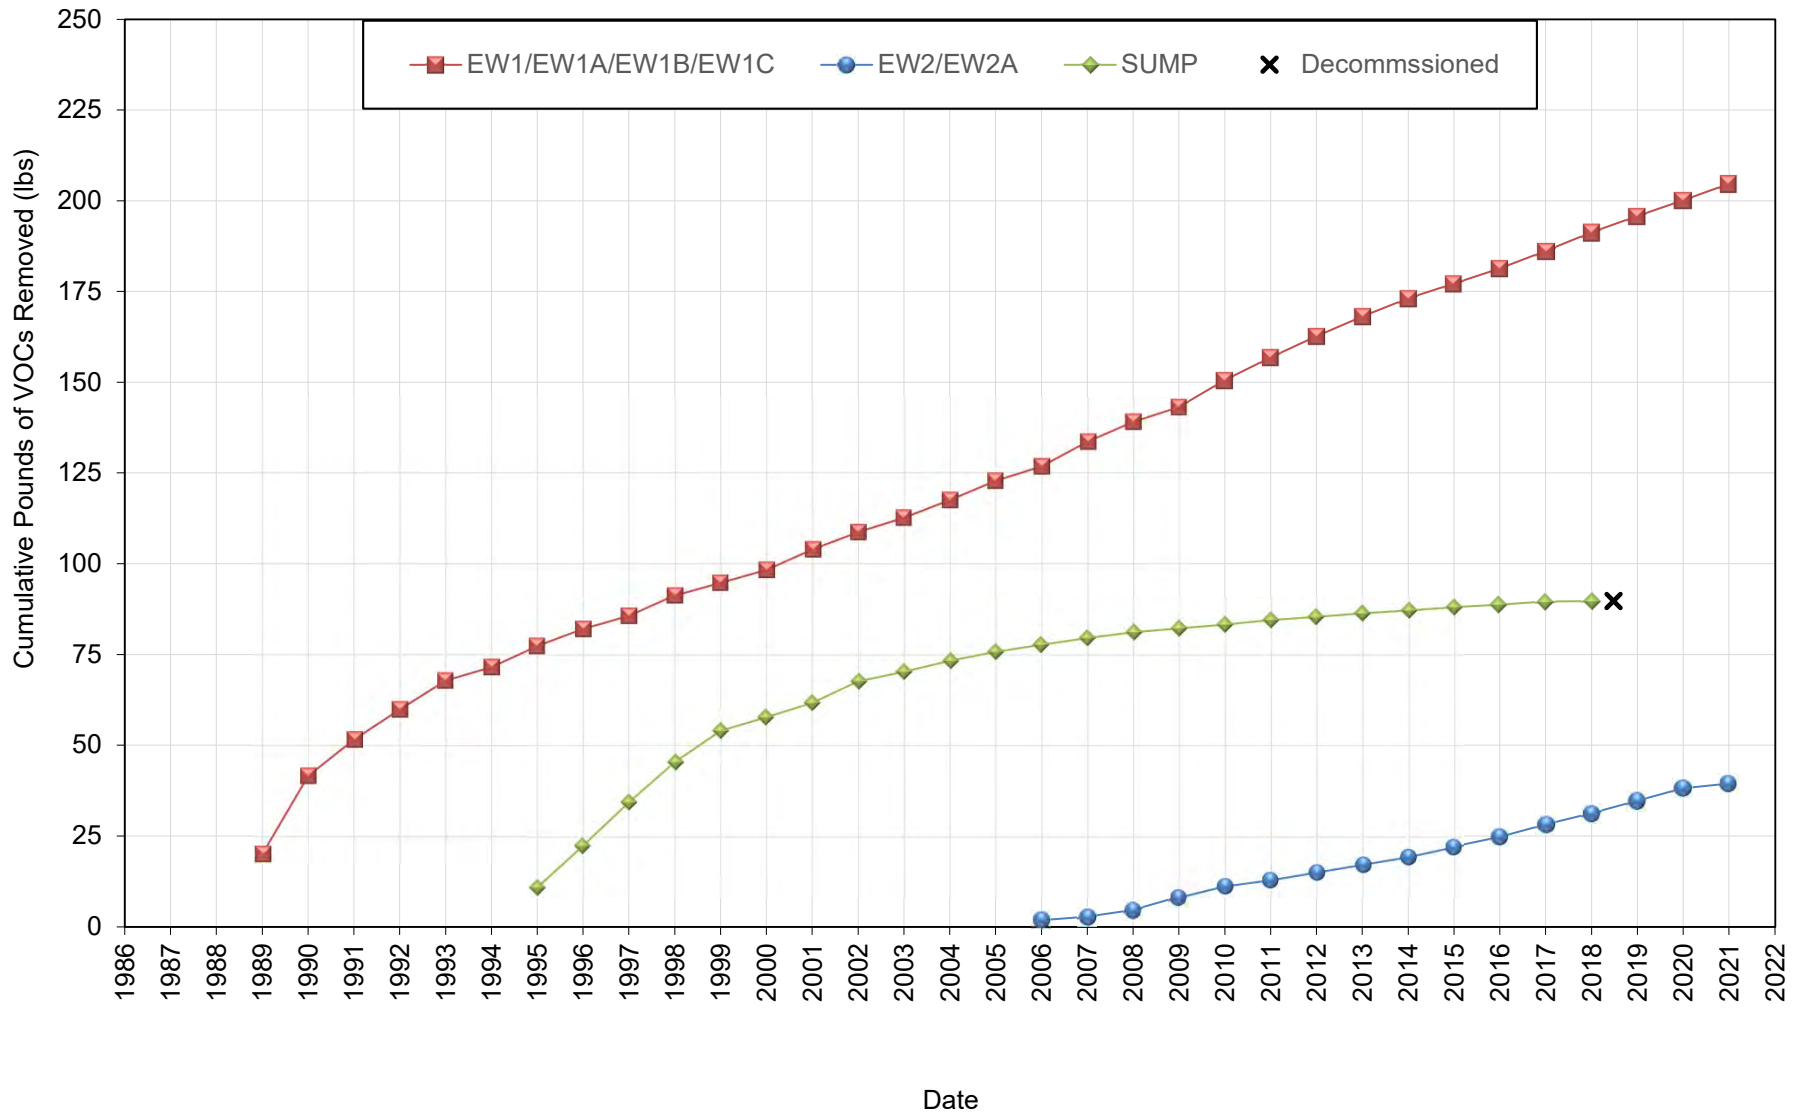
**Figure 3.9**  
**Cumulative VOC Mass Removal**  
**Highway 96 Site**  
**White Bear Township, Minnesota**

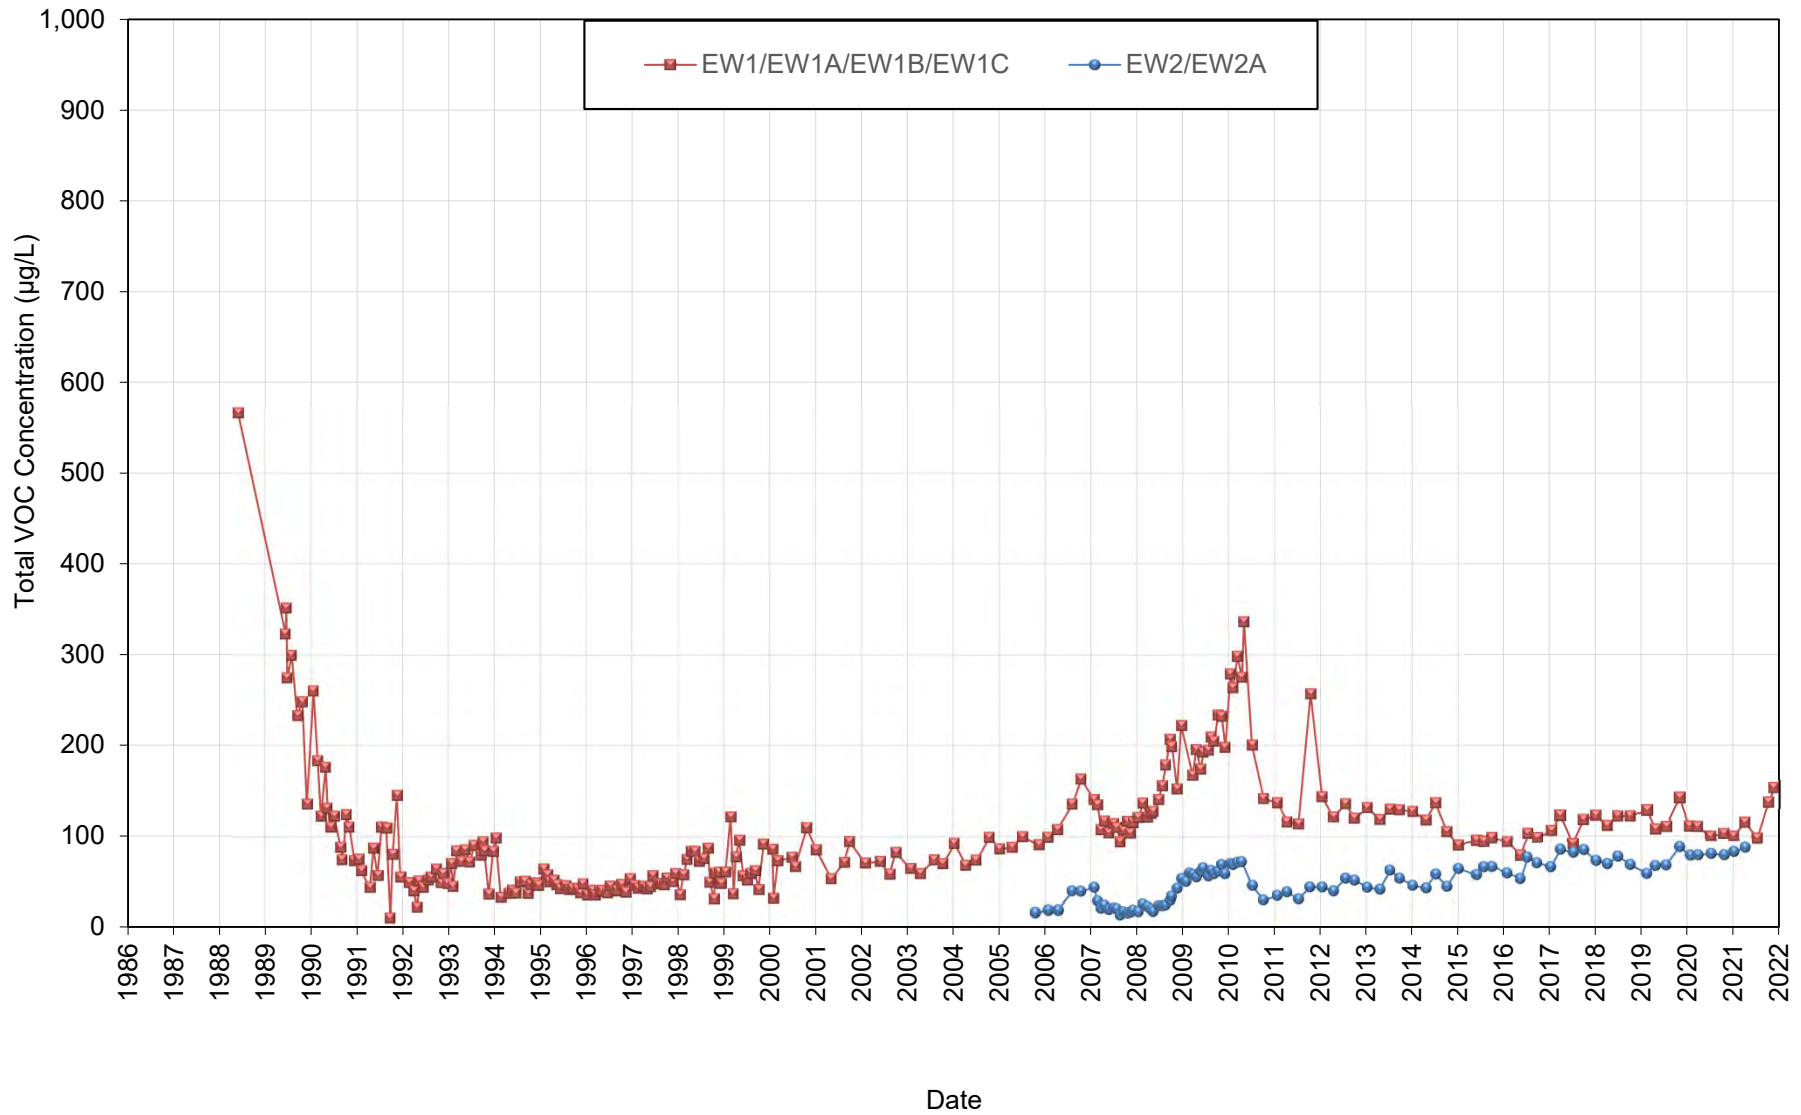
Figure 3.10 shows historic TVOC concentrations over time for EW1/EW1A/EW1B/EW1C and EW2/EW2A. As typically seen in groundwater extraction systems, TVOCs at EW1/EW1A declined during the initial pumping years from 1989 through 1996. From 1996 through 2005, TVOCs at EW1/EW1A remained at levels between 50 and 100 µg/L. When EW2 replaced EW1 in 2006, TVOCs at EW1A began increasing to levels between 100 µg/L and 300 µg/L. The increase in TVOC concentrations at EW1A was almost entirely due to increased 1,1,2-trichloroethene (TCE) concentrations. The increased TCE concentrations are likely attributed to a combination of delayed migration from the CWA and changes in the volume of groundwater extracted from the Lower Sand aquifer.

Delayed migration refers to the later release of VOCs to the Lower Sand aquifer. The CWA is located above a perched groundwater unit that is hydraulically isolated from the regional water table aquifer such that the downward migration of VOCs to the water table aquifer occurs through a zone of partially saturated soil. The rate of downward migration through this partially saturated zone is substantially less than under saturated soil conditions and is dependent on several variable parameters, such as moisture content, soil permeability, and pressure head. Hence, the downward migration rate and time required to reach the water table aquifer can vary both spatially and temporally underneath the CWA.

Changes in the volume of groundwater extracted from the Lower Sand aquifer (EW1A) occurred in conjunction with combined groundwater extraction from the upper St. Peter Sandstone aquifer (EW2), which began in 2006. TCE concentrations in the Lower Sand aquifer increased following commission of EW2 and as production decreased at EW1A due to bio-fouling issues (see Section 3.3.1). TCE concentrations in the Lower Sand aquifer have generally decreased since commission of EW1B in May 2010, except for increased concentrations observed in October 2011 when EW1B was temporarily shut down for repair.

Historical Total VOC Concentrations  
EW1/EW1A/EW1B/EW1C and EW2/EW2A  
Highway 96 Site  
White Bear Township, Minnesota

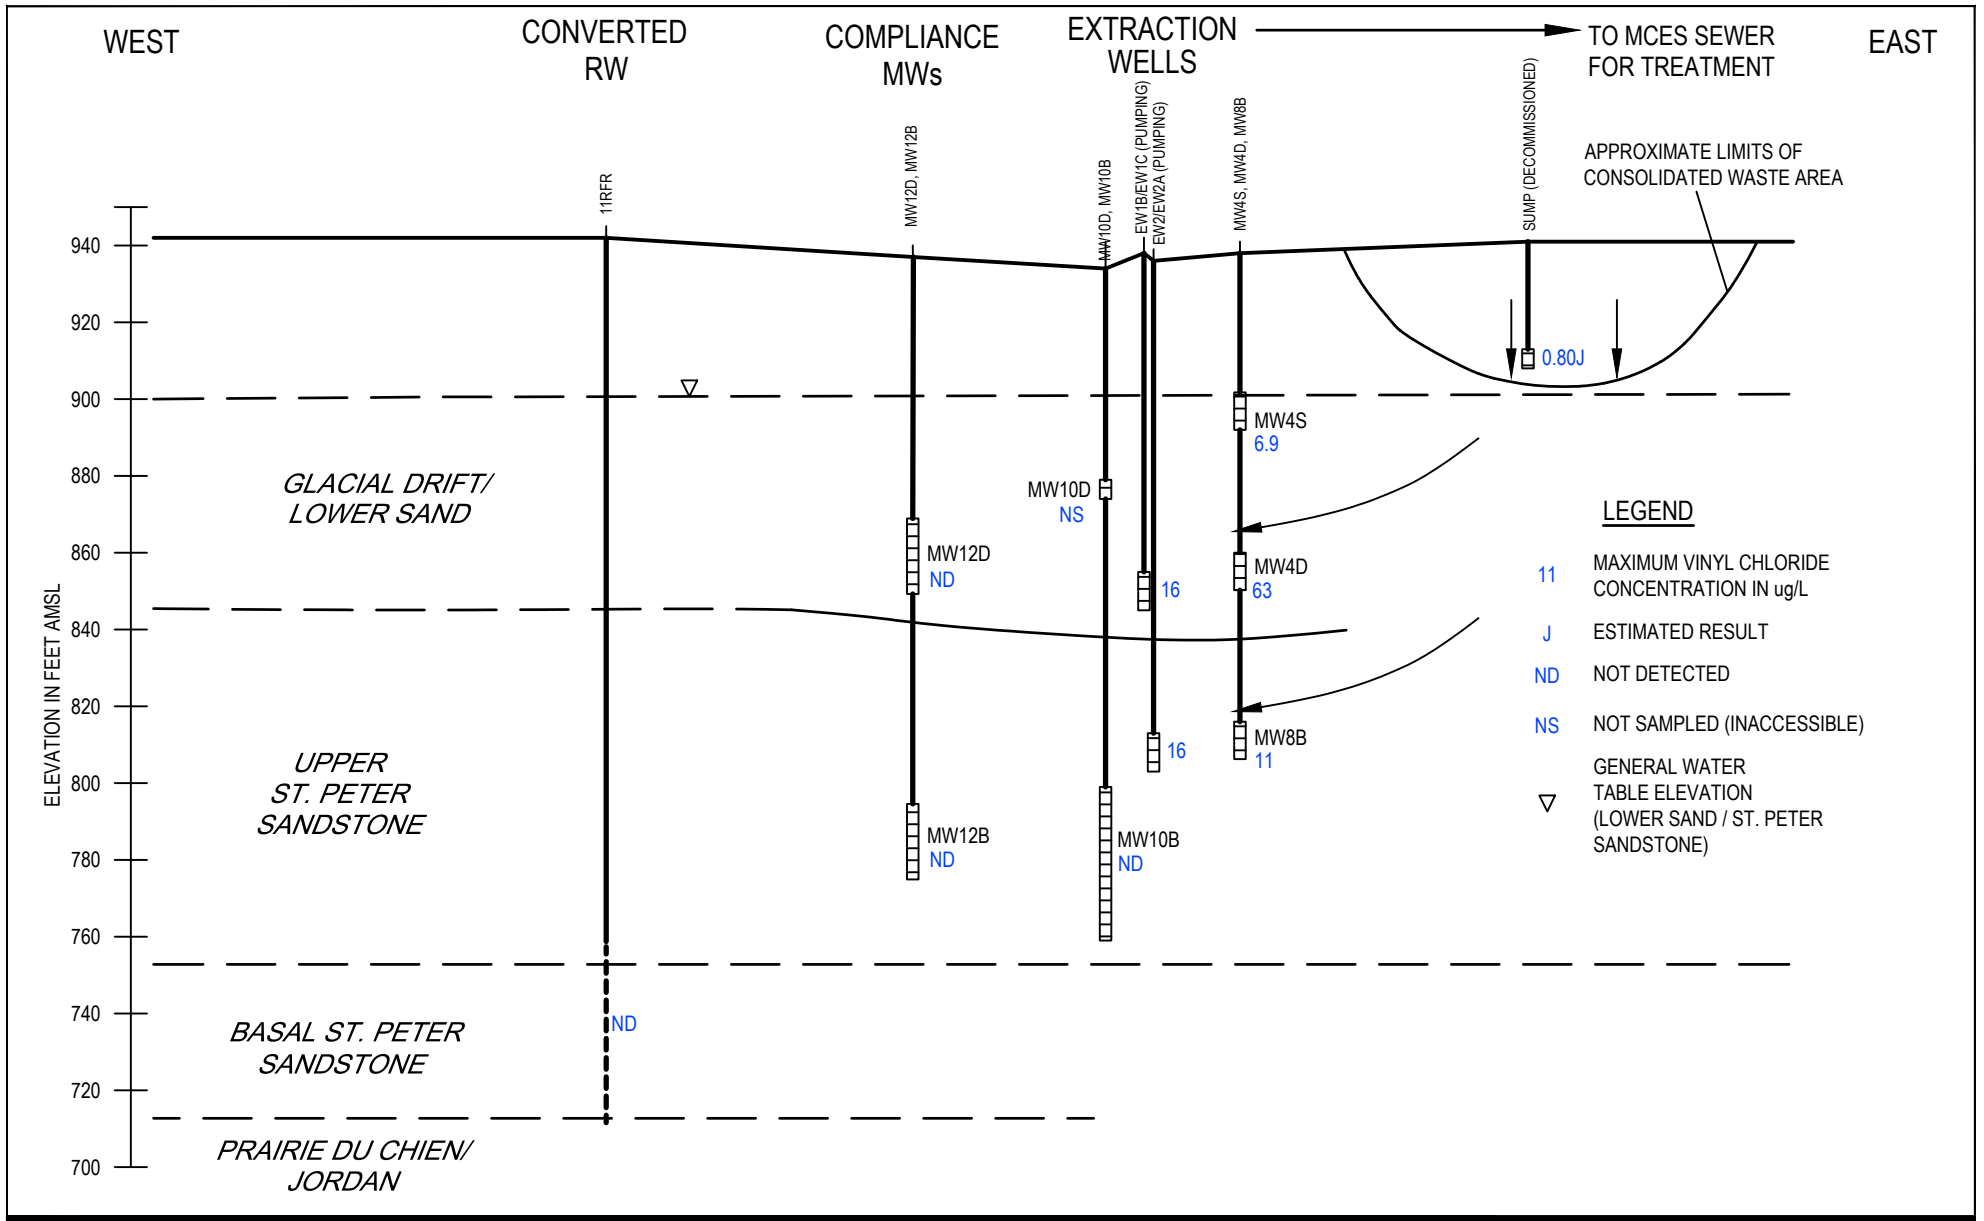
**FIGURE 3.11**

Groundwater analytical results also provide verification of hydraulic containment. Figure 3.11 presents a cross-section of the groundwater extraction system and depicts subsurface conditions along with 2021 groundwater sampling results for vinyl chloride. As shown on Figure 3.11, the groundwater extraction system captures contaminated groundwater from upgradient areas (e.g., as screened by monitoring wells MW4D and MW8B) and the effectiveness of the system is confirmed by low to non-detectable VOC concentrations at downgradient compliance wells and converted residential monitoring wells located east of Gilfillan Lake (see Section 4.3).

GROUNDWATER EXTRACTION  
CROSS SECTION (2021)

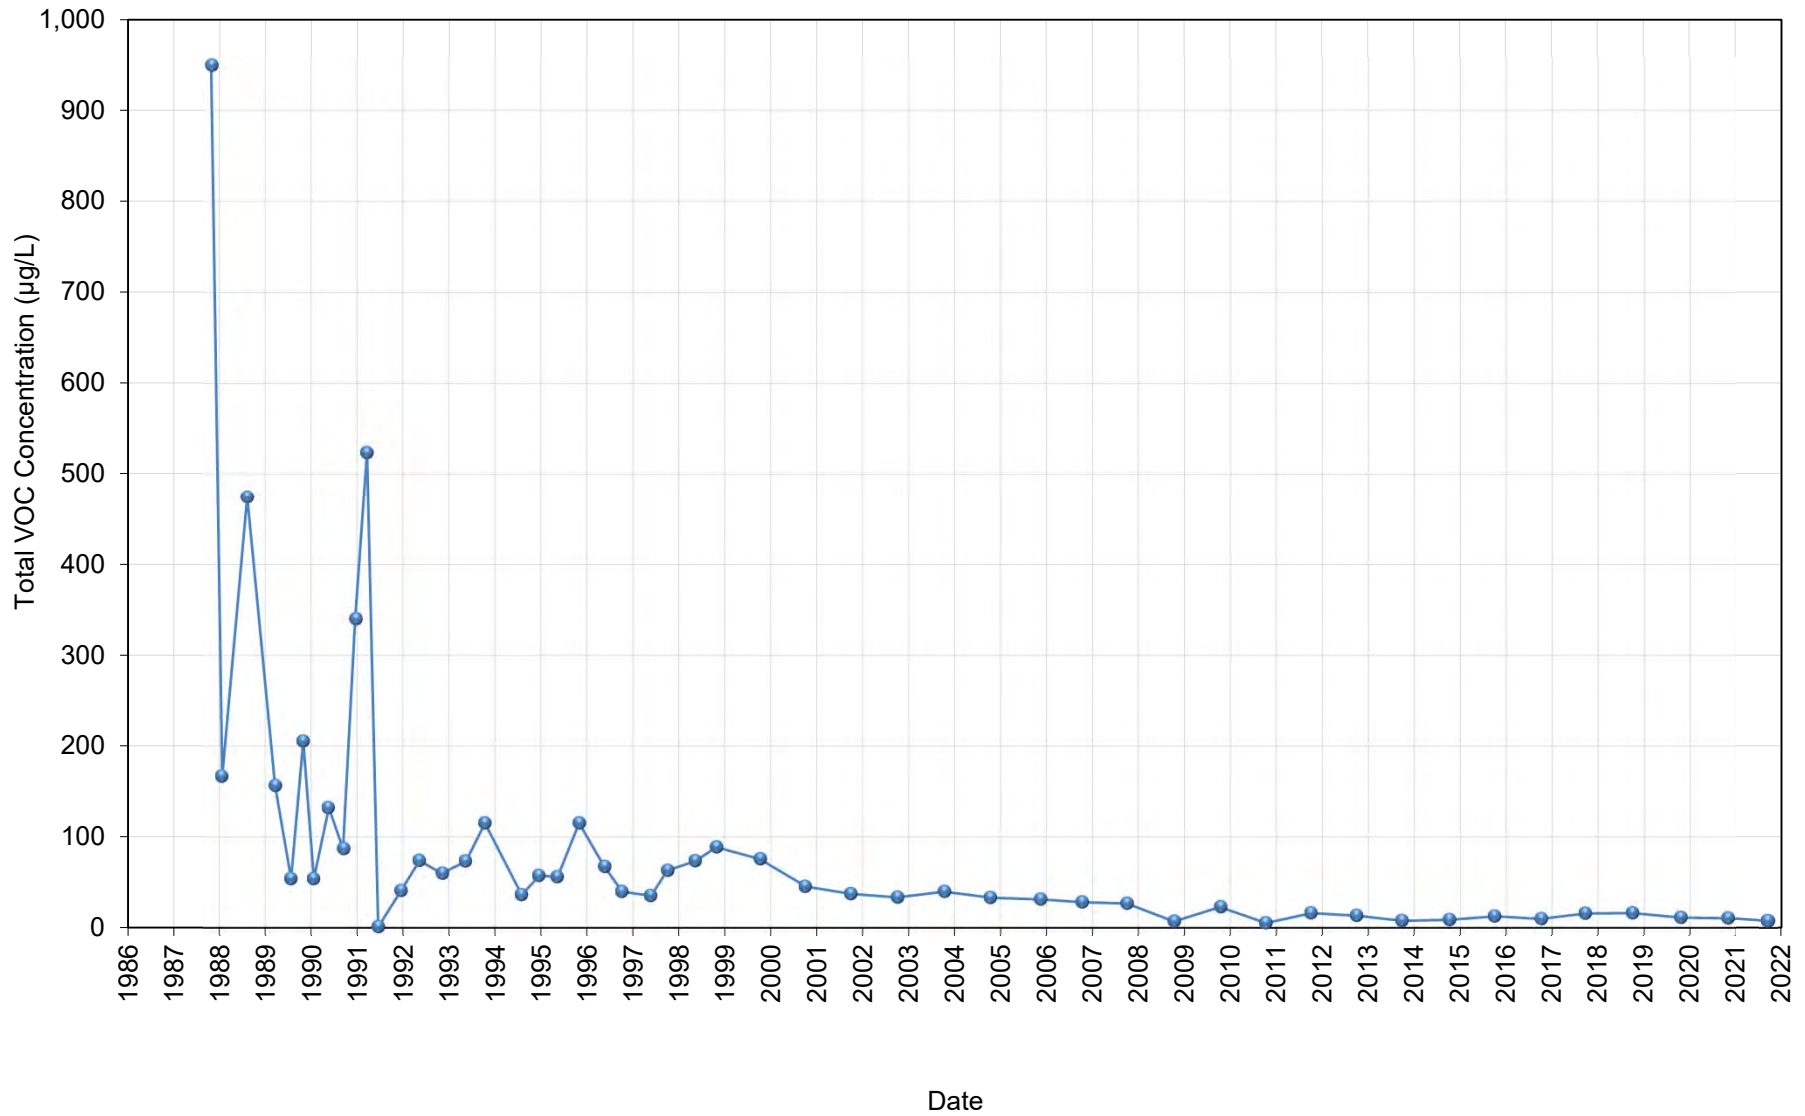
- LW3 data represent perched groundwater conditions beneath the limits of the CWA. Figure 4.1 illustrates TVOC concentrations in the perched groundwater unit decreasing from 1987 through 1991 and remaining relatively stable and less than 50 µg/L since 2001. In 2021, the TVOC concentration at LW3 was 7.41 µg/L.

**Figure 4.1**  
**Historical Total VOC Concentrations**  
**LW3**  
**Highway 96 Site**  
**White Bear Township, Minnesota**
