# **2021 Annual Monitoring Report**

**Highway 96 Site  
White Bear Township, Minnesota**

Highway 96 Site PRP Group

March 15, 2022

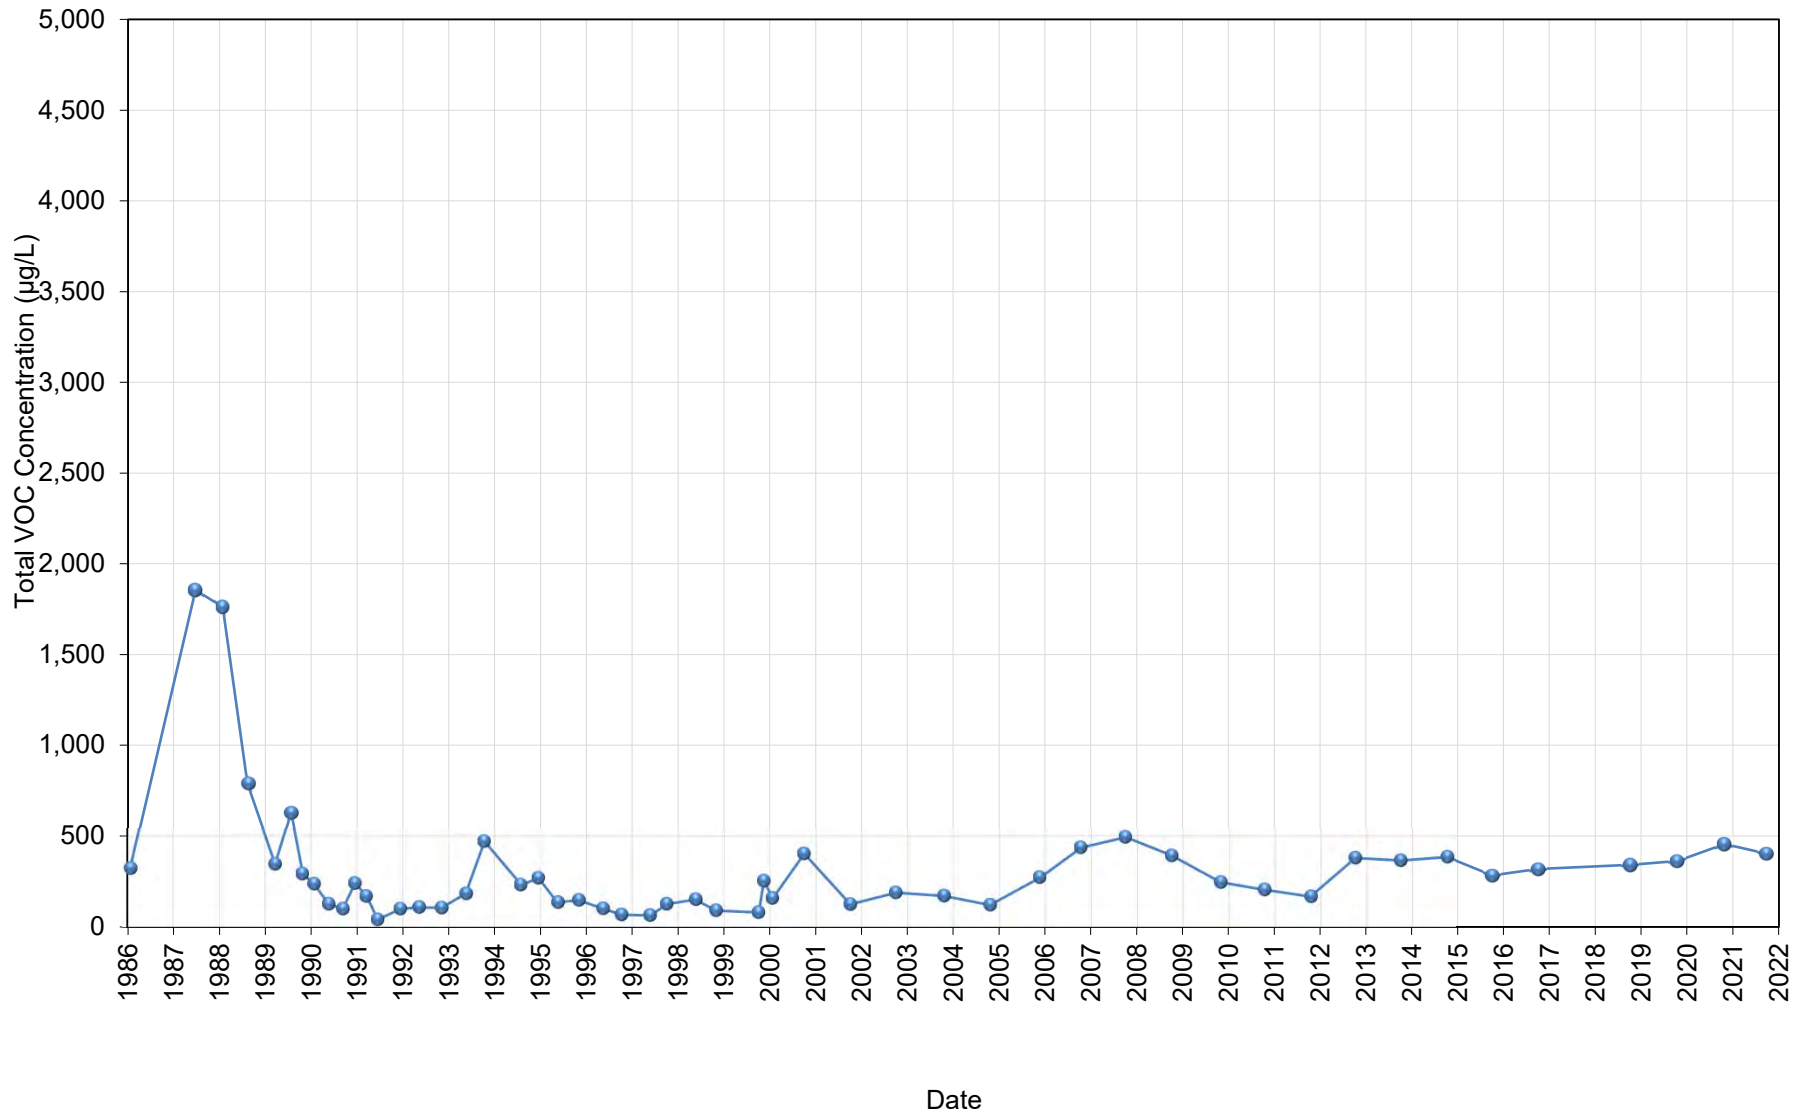
- MW4D data represent groundwater conditions in the Lower Sand aquifer immediately downgradient of the CWA. Figure 4.2 illustrates TVOC concentrations at MW4D decreasing from 1987 through 1991 and ranging from 50 µg/L to 500 µg/L since 1991. In 2021, the TVOC concentration at MW4D was 403.4 µg/L.

**Figure 4.2**  
**Historical Total VOC Concentrations**  
**MW4D**  
**Highway 96 Site**  
**White Bear Township, Minnesota**

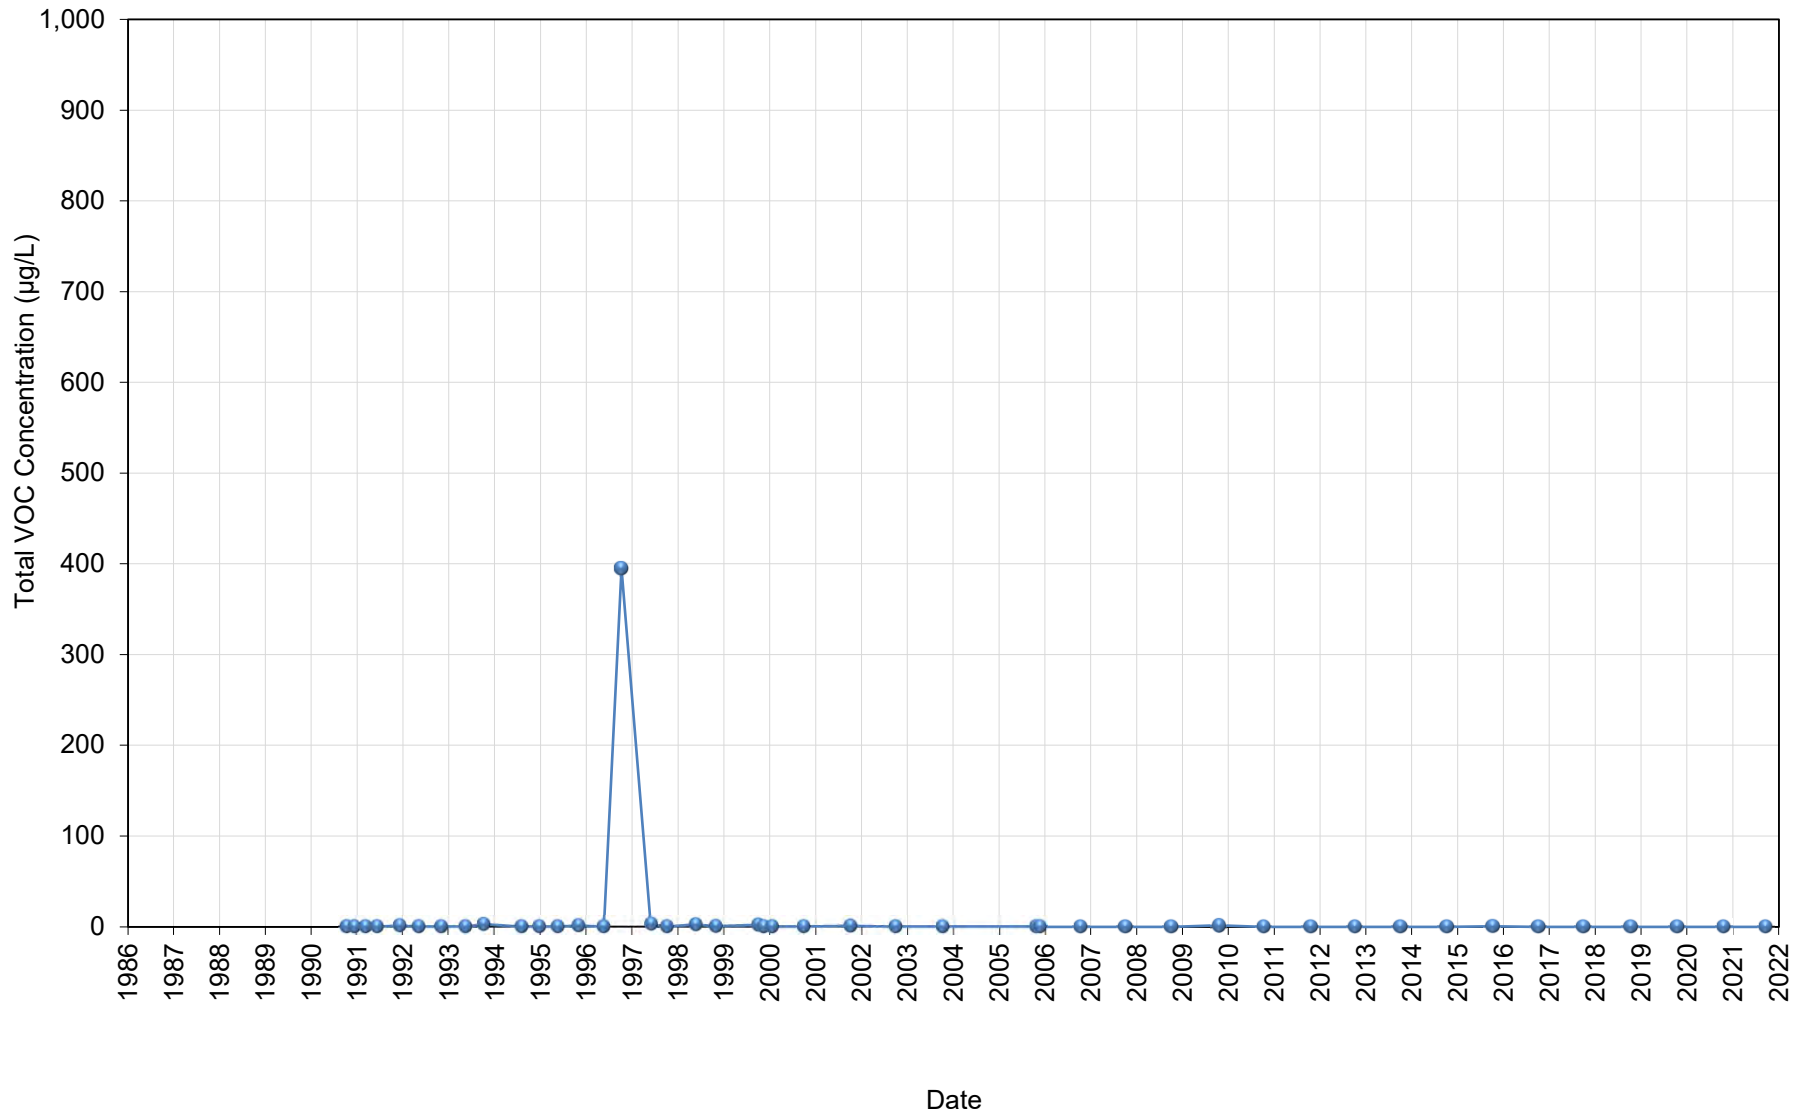
- MW12D is a compliance well located between the extraction system and Robb Farm Road. MW12D data represent groundwater conditions in the Lower Sand aquifer immediately downgradient of the extraction system. Figure 4.3 illustrates TVOC concentrations at MW12D, which have historically remained below 3 µg/L since 1997. In October 1996, the TVOC concentration was near 400 µg/L. That sample result is considered anomalous because TVOC concentrations were not observed at or near that level prior to or after that sample date. In 2021, no VOCs were detected at MW12D.

**Figure 4.3**  
**Historical Total VOC Concentrations**  
**MW12D**  
**Highway 96 Site**  
**White Bear Township, Minnesota**

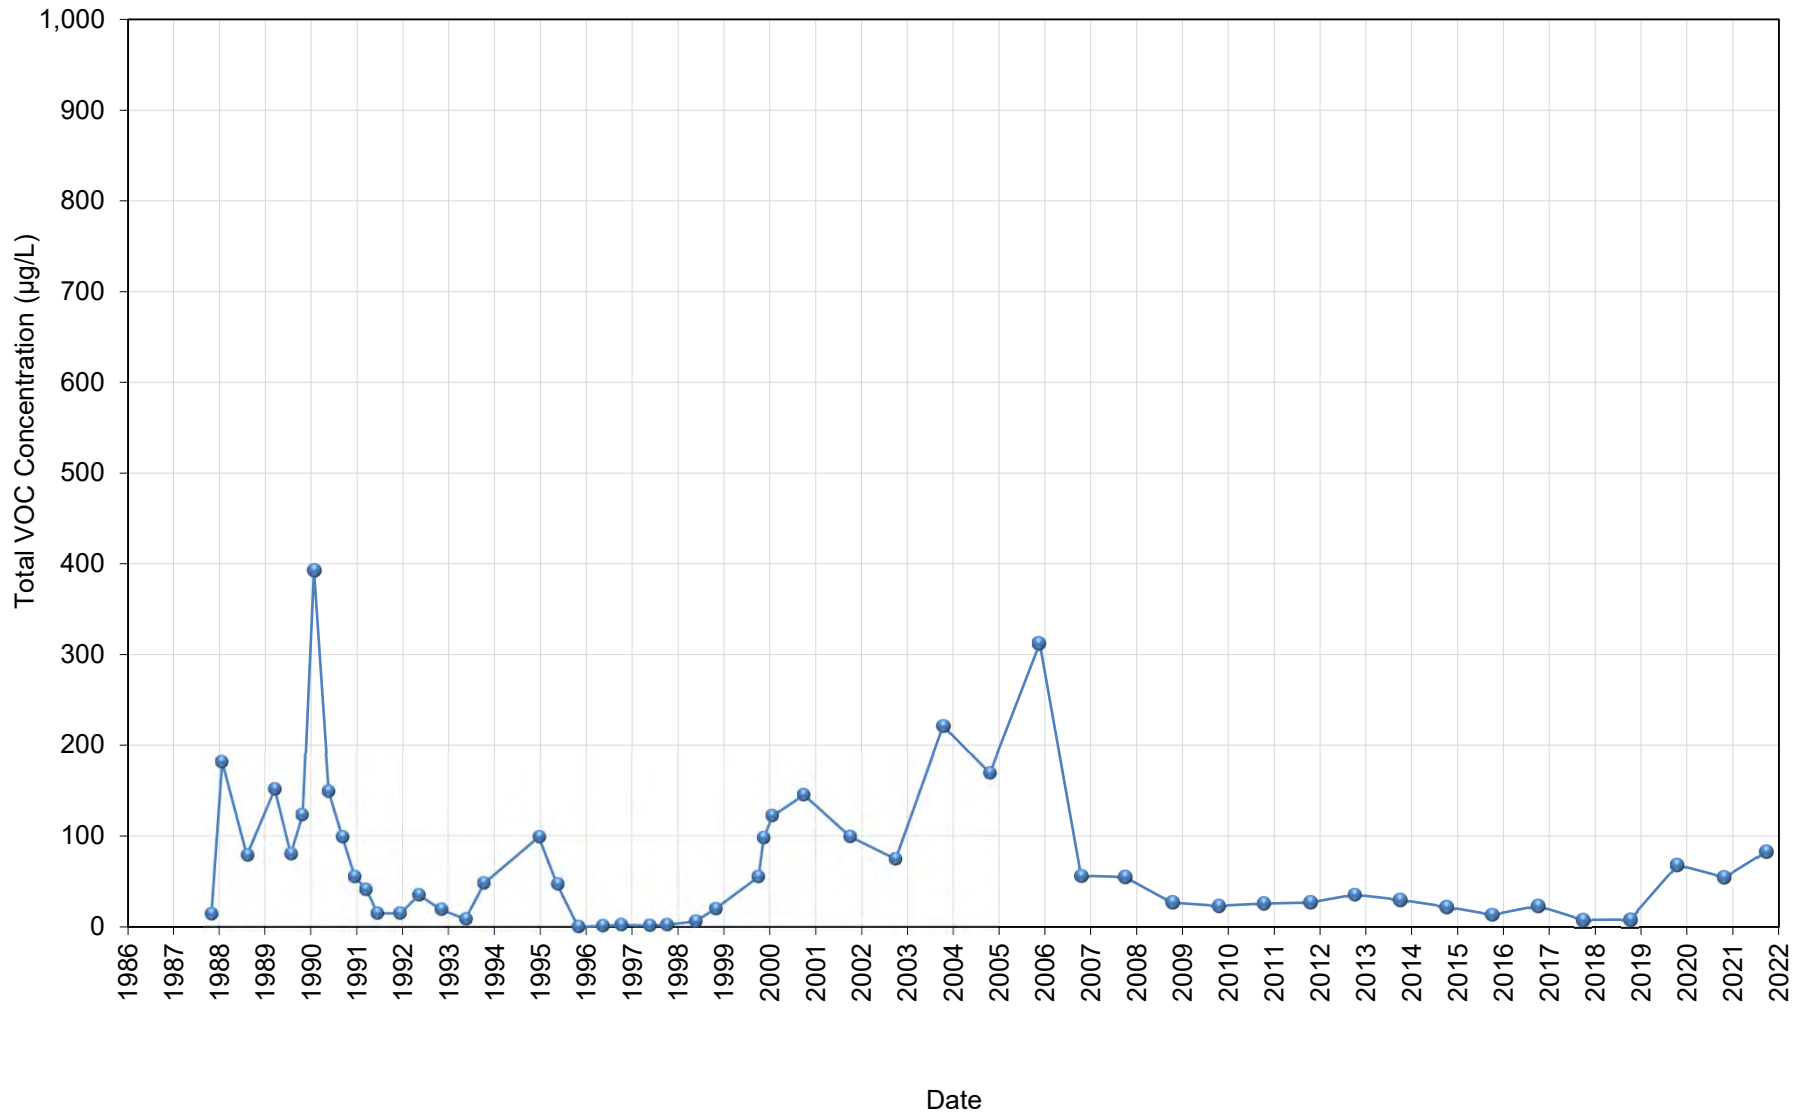
- MW8B is located between the CWA and the groundwater extraction system. MW8B data represent groundwater conditions in the St. Peter Sandstone aquifer immediately downgradient of the CWA. Figure 4.4 illustrates TVOC concentrations at MW8B, which have ranged from 1 µg/L to 300 µg/L since sampling began in 1987. TVOC concentrations at MW8B have remained below 100 µg/L since the commission of extraction well EW2 in January 2006. In 2021, the TVOC concentration at MW8B was 83.11 µg/L.

**Figure 4.4**  
**Historical Total VOC Concentrations**  
**MW8B**  
**Highway 96 Site**  
**White Bear Township, Minnesota**

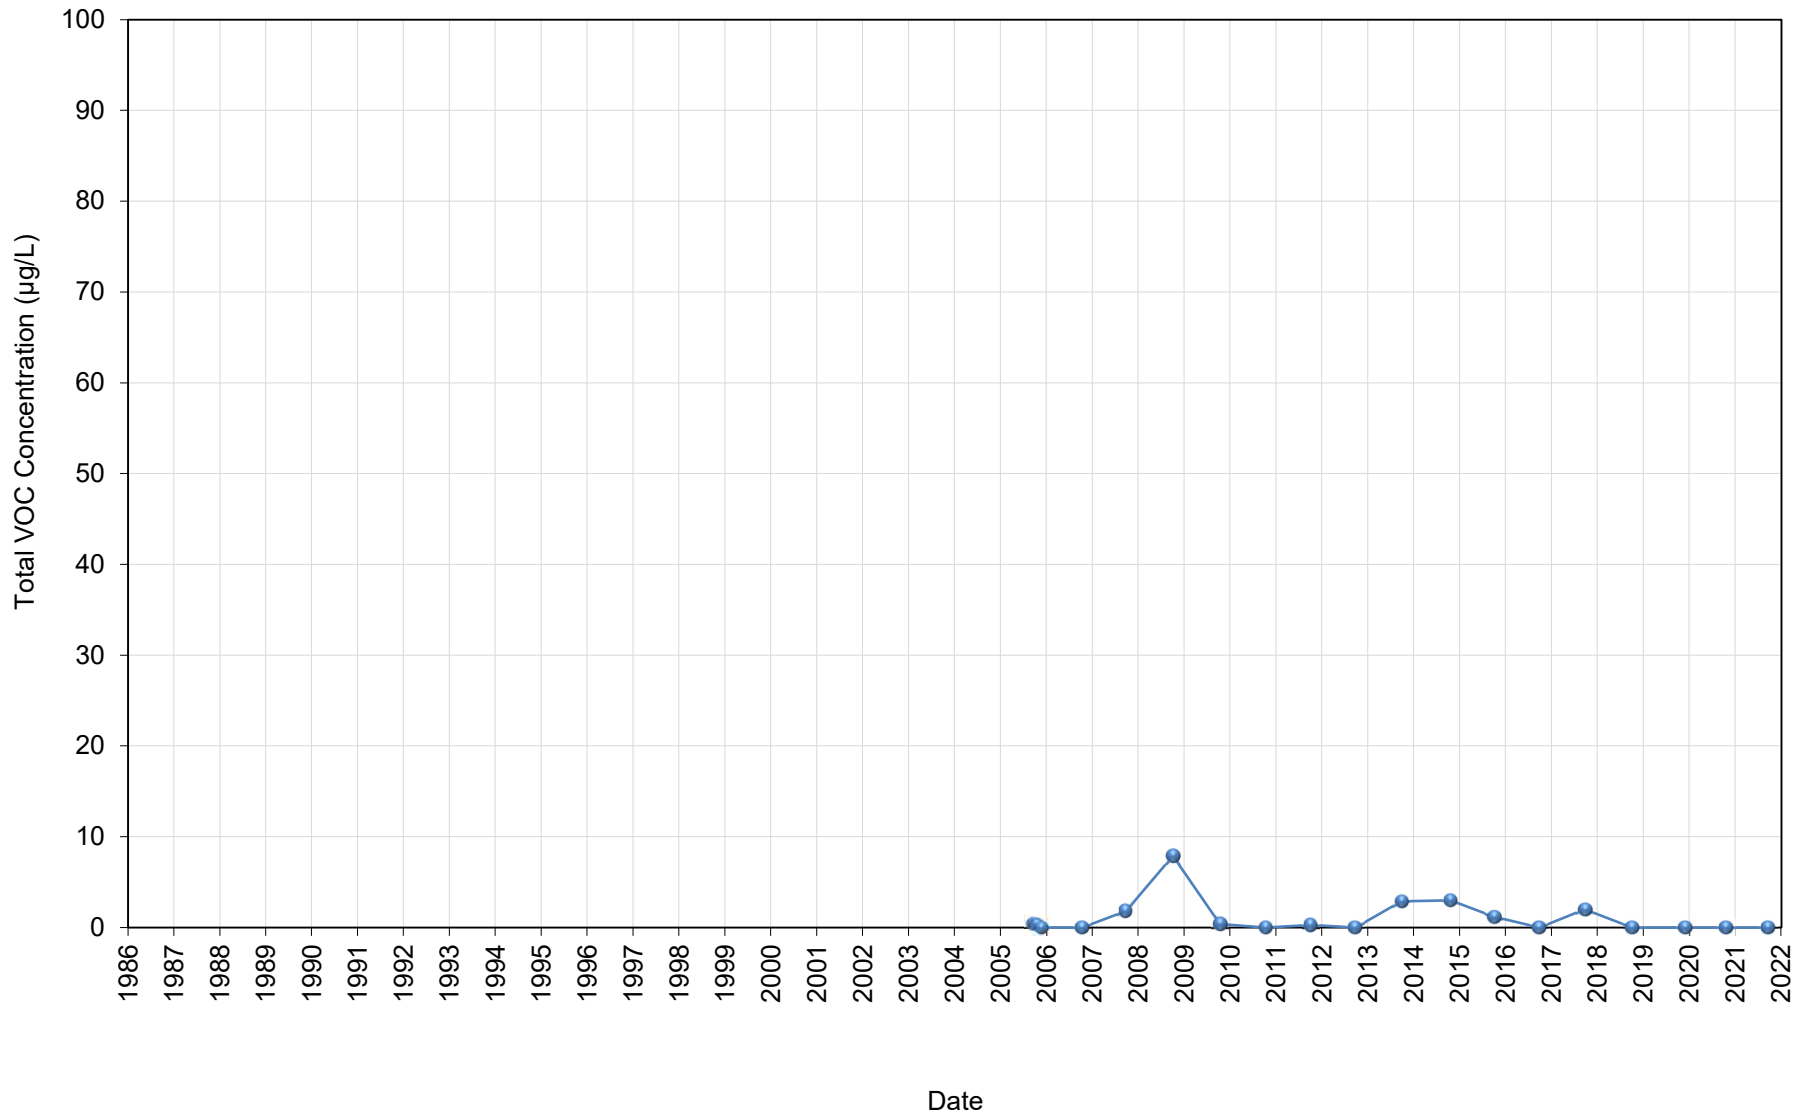
- MW17L data represent groundwater conditions in the Prairie du Chien aquifer downgradient of the Highway 96 Site. Figure 4.10 illustrates that TVOC concentrations at MW17L have remained below 10 µg/L since sampling began at this location in 2005. In 2021, no VOCs were detected at MW17L.

**Figure 4.10**  
**Historical Total VOC Concentrations**  
**MW17L**  
**Highway 96 Site**  
**White Bear Township, Minnesota**

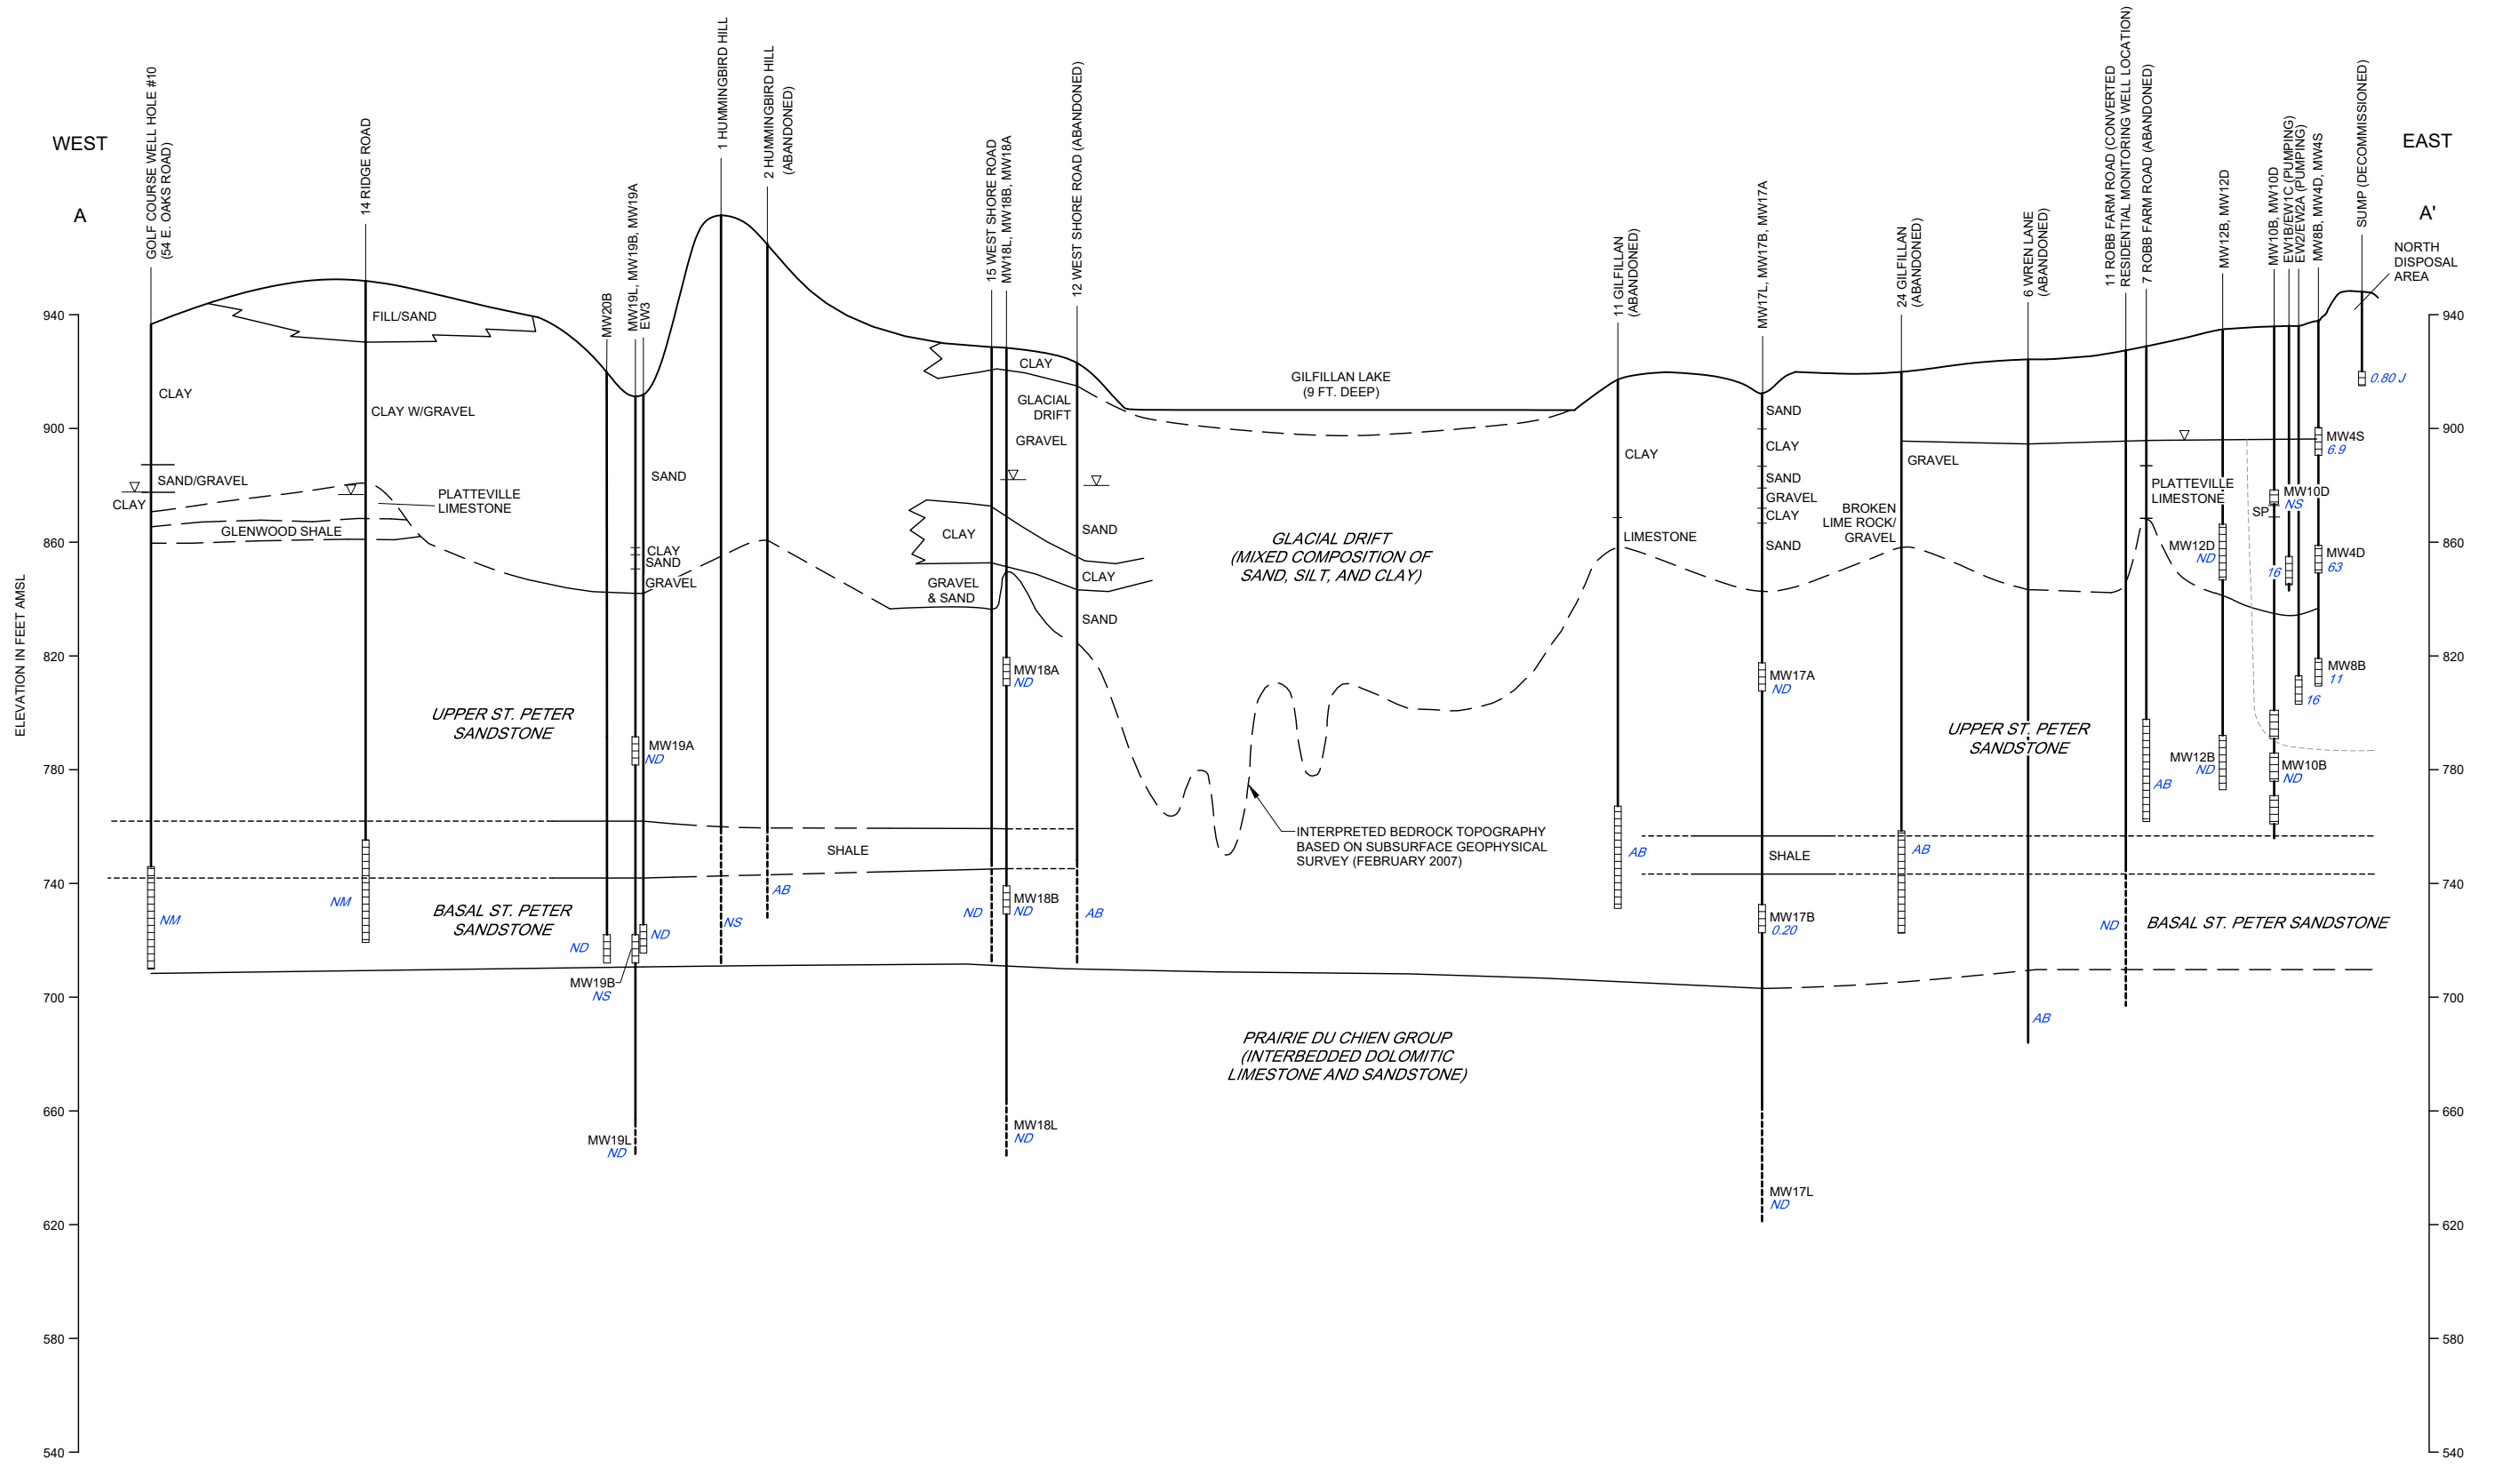
FIGURE A.1

GEOLOGIC CROSS SECTION A-A'
