2020 Annual Monitoring Report

Highway 96 Site
White Bear Township, Minnesota

Highway 96 RP Group

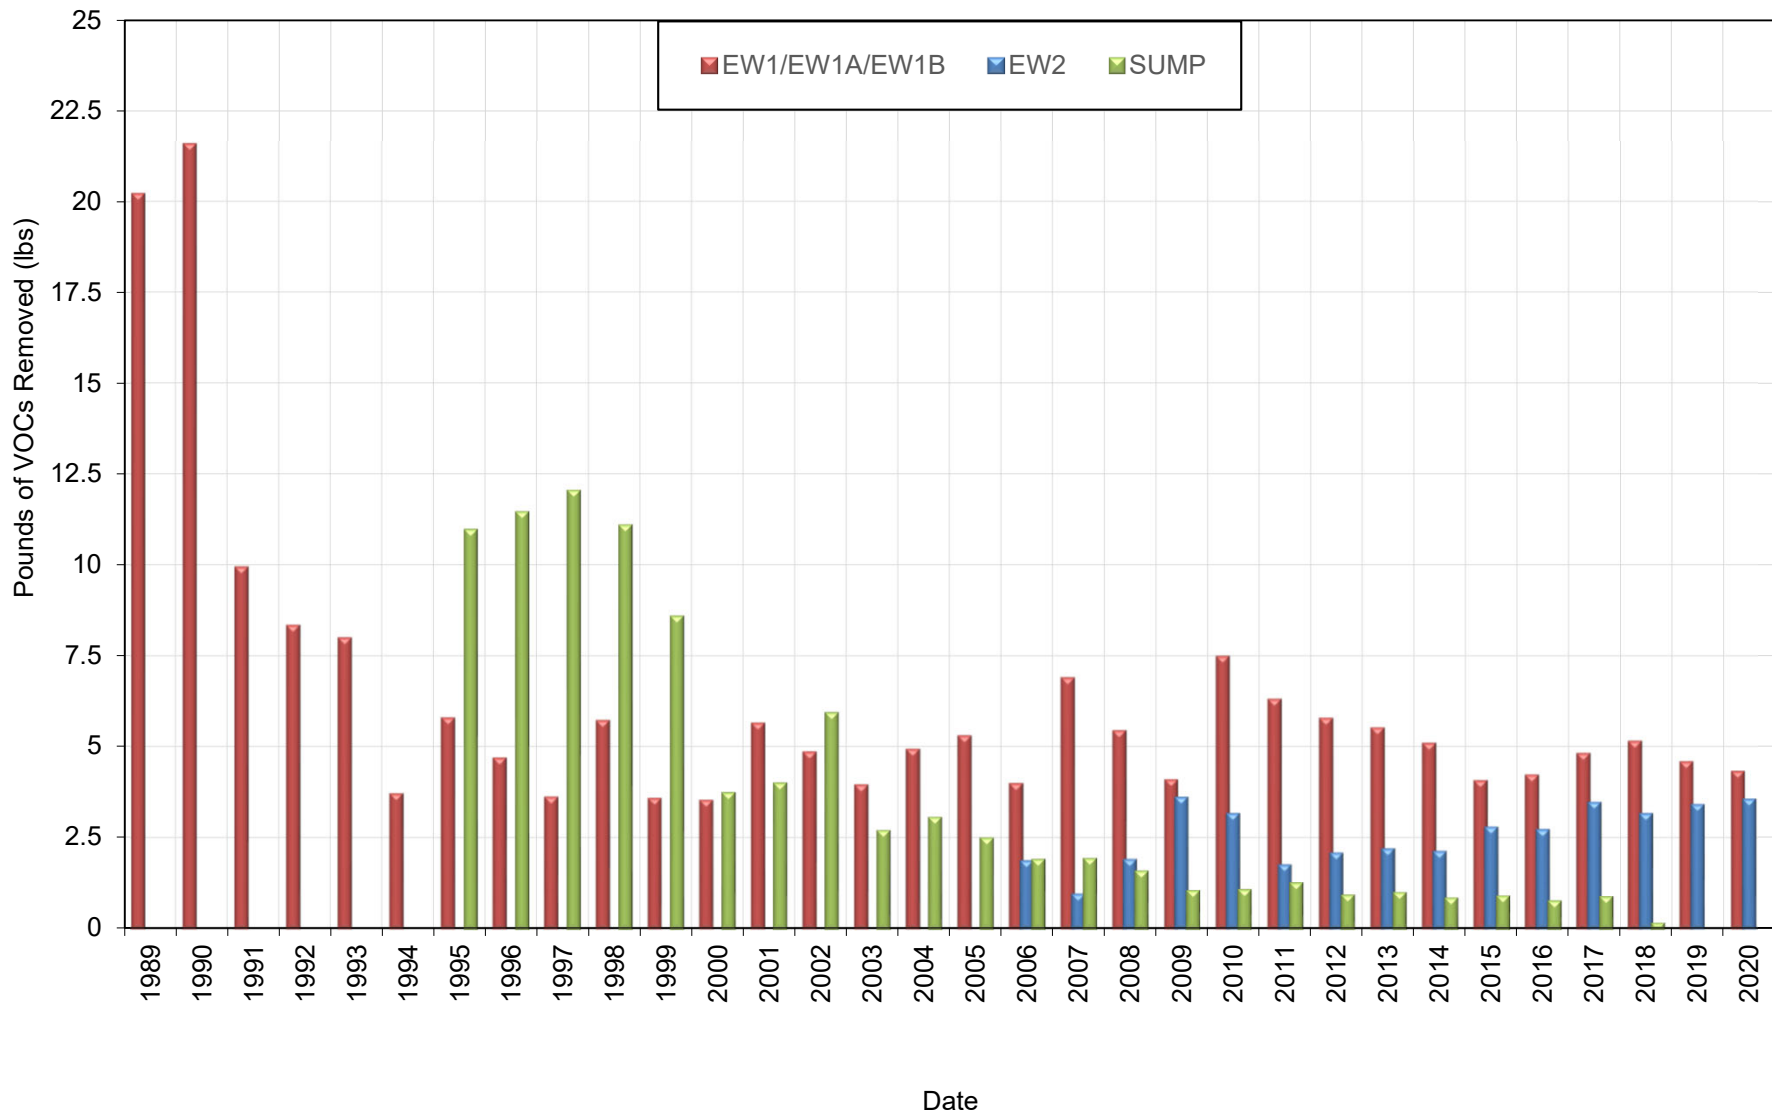
Figure 3.7

Historical VOC Mass Removal
Highway 96 Site
White Bear Township, Minnesota

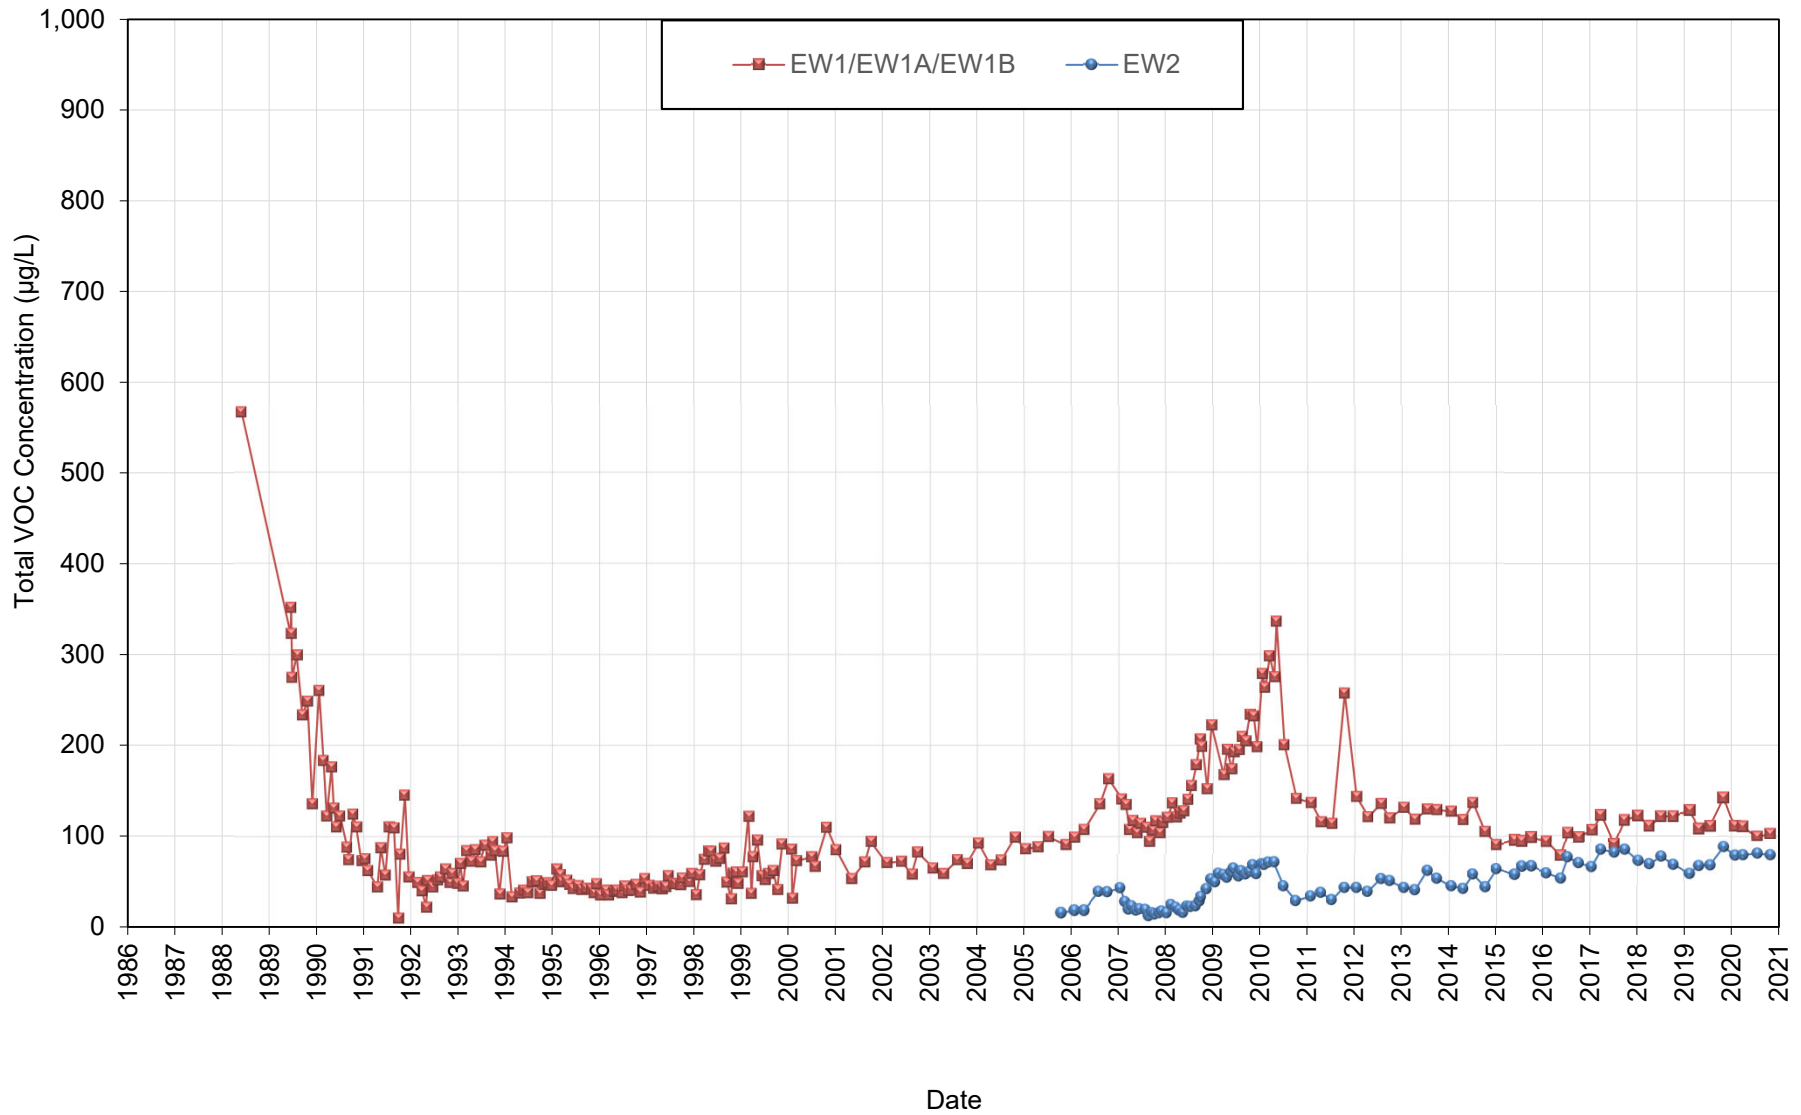
Historical Total VOC Concentrations
EW1/EW1A/EW1B and EW2
Highway 96 Site
White Bear Township, Minnesota

Figure 3.10 shows historic TVOC concentrations over time for EW1/EW1A/EW1B and EW2. As typically seen in groundwater extraction systems, TVOCs at EW1/EW1A declined during the initial pumping years from 1989 through 1996. From 1996 through 2005, TVOCs at EW1/EW1A remained at levels between 50 and 100 µg/L. When EW2 replaced EW1 in 2006, TVOCs at EW1A began increasing to levels between 100 µg/L and 300 µg/L. The increase in TVOC concentrations at EW1A was almost entirely due to increased 1,1,2-trichloroethene (TCE) concentrations. The increased TCE concentrations are likely attributed to a combination of delayed migration from the CWA and changes in the volume of groundwater extracted from the Lower Sand aquifer.
